THE TORQUE CONVERTER JOURNAL

VOLUME **1** NUMBER **2**

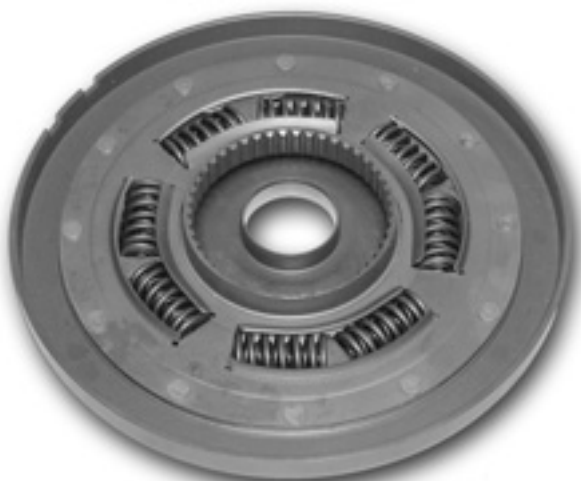
When the converter is cut open, you'll want to check the friction material on the clutch plate and the mating surface on the cover for signs of clutch slippage. If these look good, turn the clutch over and examine the damper assembly (see Figure 1). This is the time when the finger-pointing usually starts, and the converter rebuilder feels confident enough to suggest that the transmission technician had better look at his work a little more closely.

Figure 1
Jatco damper assembly, TCC clutch and damper assembly.

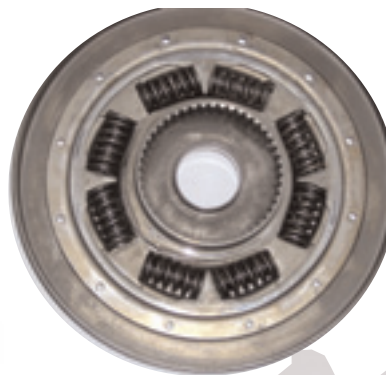
In this case, the failed part was inside the torque converter. The mechanical link that connects the turbine hub to the springs of the damper assembly has four tabs where it contacts the springs. These tabs had broken off, so that there was no longer a link between the turbine hub and the damper assembly. The lockup clutch is the driving member when the torque converter is in lockup mode, so it could no longer physically turn the turbine hub with this link broken. Since the turbine was no longer able to rotate 1:1 with the rest of the converter (like it should in lockup mode), heat was generated. When you refer back to Figure 1 you can see how easy it was to miss this broken part because the broken parts are completely contained within the damper assembly. Nothing can come out and self-destruct the unit,

which is a good thing, dollar-wise, but can really raise your frustration level. In Figure 2 you can see what the broken parts look like with the top retaining plate removed.

Figure 2
Damper assembly with top plate removed.

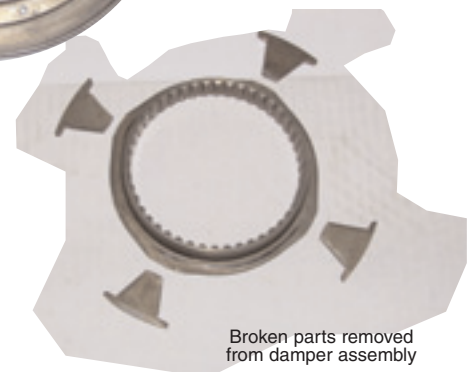
Broken parts removed from damper assembly
