TROUBLESHOOTING THE 4T65-E

A Matter of Interpretation

by Bob Warnke

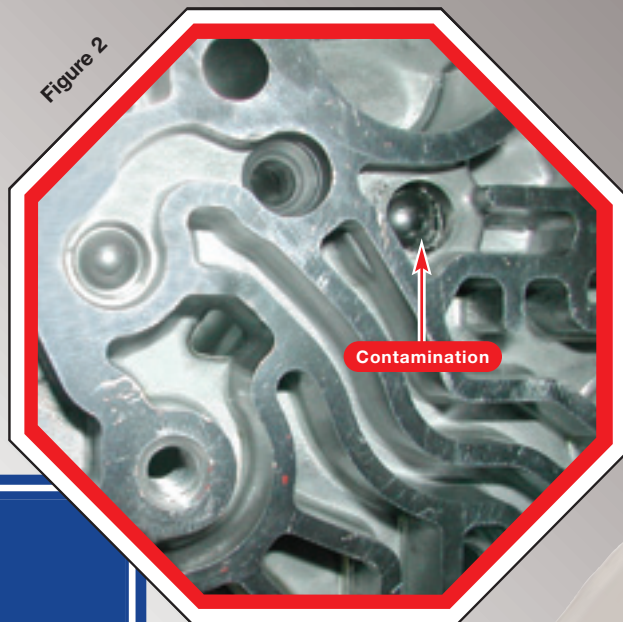
Figure 2

In Figure 2, you can see contamination stuck around the return cooler checkball seat. The evidence is there, but the interpretation that must be made is whether the particles are leaving the transmission or returning from the cooler.

But what if we have not seen or cannot see this, as in Figure 4? This photo shows a 4T65-E 258mm TCC piston that has been overpressurized. Where do you think the material that gets ground from its surface winds up? You guessed it. It collects by the checkball back in Figure 2. Build up enough of this contamination and what do you suppose happens then? Correct. Now it's time to pull the latch for the technician in Figure 3 so he can

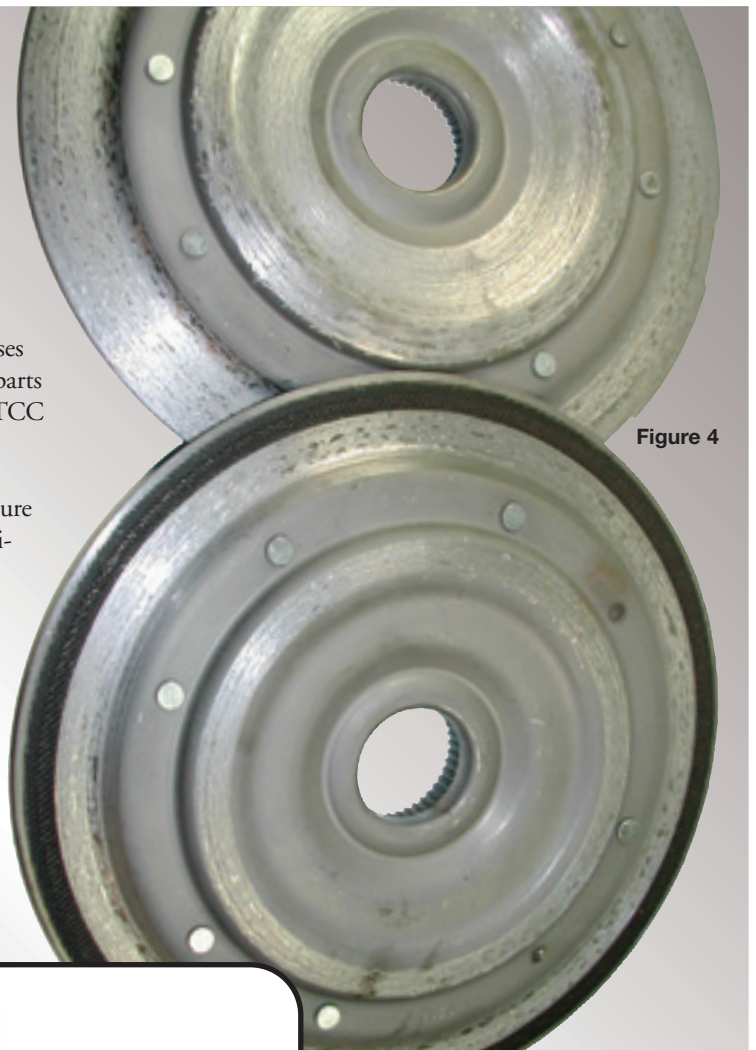
Figure 4

Unless you have cut the converter open, this failure may be unknown except for traces of stray material in the oil pan and cooler circuit. Earlier drivability complaints include transmission noise, no movement as the filter gets plugged, harsh TCC apply, stall on engagement or coastdown shudder.

Looking closely at Figure 4, starting from the outer edge of the piston, you can see the various stages of lining damage, then onto piston failure. Overpressurization of the TCC piston dur-

To be brief, it flows like this: Line pressure from the pressure regulator valve goes to the AFL valve, which limits the maximum pressure to the pressure control (EPC) solenoid. EPC control is directed by the line by way of the boost sleeve. Line pressure flows through the TCC regulator valve to apply the TCC piston. Incorrect operation of any of these valves can potentially increase both line and apply pressure, creating the damage you see in Figure 4.

ing apply originates from various sources (see Figure 5). We can now look to repairs such as the Sonnax boost valve & sleeve kit, **84754-30K**, and the TCC regulated apply valve, **84754-34K**, to correct the hydraulic concerns that lead to this damage. Further, we can add the new Sonnax relief valve, **84757-01K**, to ensure the PCM cannot elevate apply pressure beyond the material strength of the converter piston.

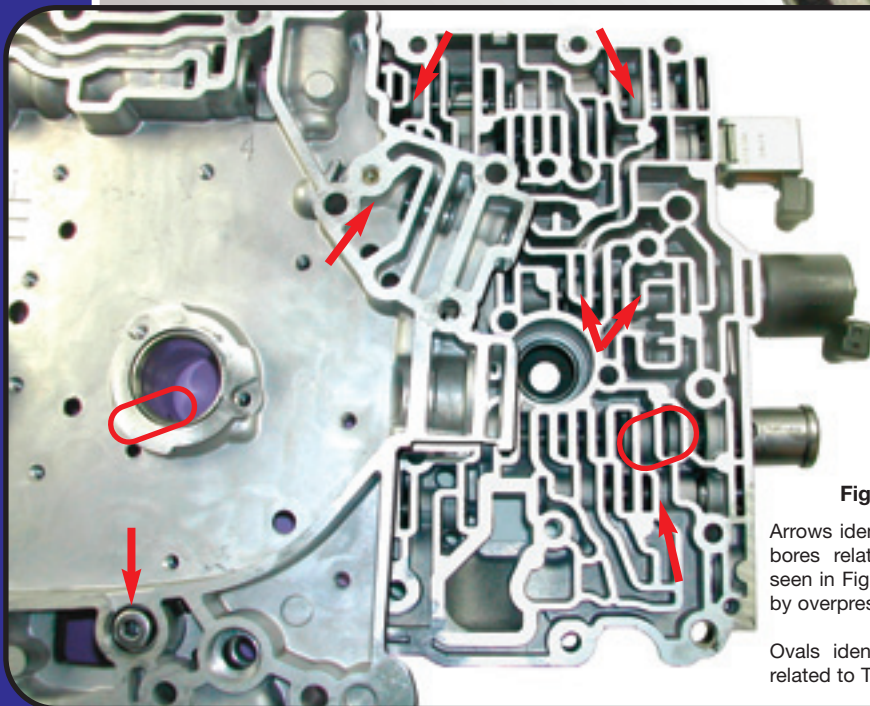
Figure 5

Arrows identify the valve bores related to failure seen in Figure 4, caused by overpressurization.

Ovals identify concerns related to TCC slippage.
