4T65Es and the Mysterious Code P0730

Article No.: T3-EL-06-04

Author: Ed Lee

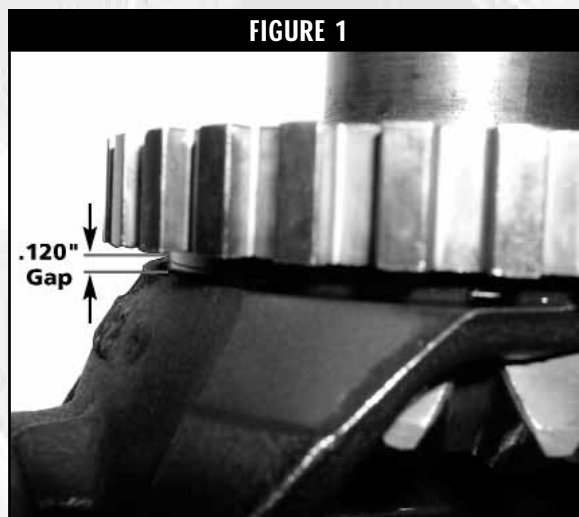
FIGURE 1

Since all of the ratios were off by 10%, the technician reasoned that the code was most probably not set by component slippage. He also figured that since the slippage seemed to be consistent, the problem was probably something related to data supplied by either the input speed sensor (ISS) or the vehicle speed sensor (VSS).

The ISS signal compared favorably to the engine rpm, so that was ruled out. The PCM compares the known axle ratio to a calculated ratio for each gear range, so the PCM was checked to verify that it was correct for the vehicle (correct known axle ratio). The PCM was proved to be correct so the technician zeroed in on the final drive and the final drive's reluctor. The vehicle was put on the lift and the differential was removed. The final drive turned out to be the correct ratio for the vehicle and the reluctor had the correct tooth count.

The light at the end of the tunnel seemed to be fading fast at this point, and then the technician noticed a clue. The reluctor is supposed to be butted flush to the differential. On this differential, the reluctor had a .120-inch gap between it and the differential (see Figure 1).

sufficient to expand the reluctor enough to free the wheel on the differential. Replacing the reluctor did eliminate the P0730 code.

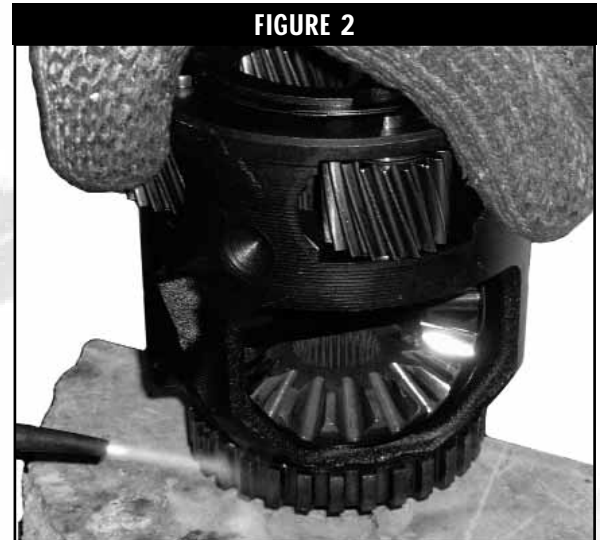
FIGURE 2

the reluctor. The final drive was placed on the bench with the reluctor facing down. The final drive was slowly rotated while the reluctor was heated with a torch (see Figure 2). On or after three revolutions the reluctor usually falls off. In this case the reluctor fell off as soon as the heat from the torch touched it. The reluctor was not even warm to the touch, but would spin freely on the differential. After about 10 minutes the reluctor again would not turn independently of the differential. Normal operating temperatures were

If you have had a P0730 code in the past that you ended up replacing a unit to correct, you may want to revisit that unit. Pull the differential and do the torch test. If it falls off immediately, you will only have to replace the reluctor to have a good stock unit.
