"Factory Style" Large Reverse Boost Valve & Sleeve Kit

K77898A

Sonnax Part Summary

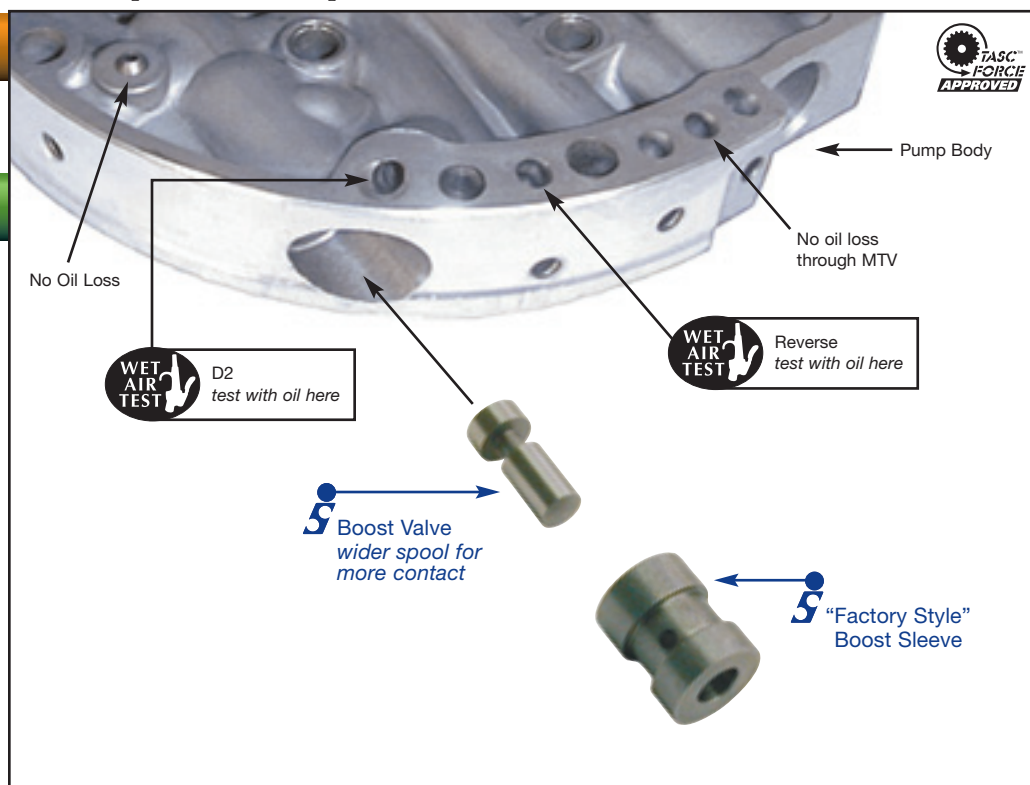
Poor reverse boost, delayed reverse

• Low line pressure • Poor upshift in manual low

Worn reverse boost valve sleeve or wear at pump body.

Vehicles with a 700-R4 transmission often have complaints of poor reverse boost or upshifts in manual low. This complaint is generally caused by a worn reverse boost valve sleeve or wear at the pump body. Sonnax now offers the larger (.283") "Factory style" reverse boost valve assembly **K77898A**. The sleeve and valve are made from hardened steel, and tight tolerances are maintained to restore the hydraulic integrity of the assembly.

The sleeve lands have also been lengthened to add better sealing and stabilizing capabilities to prevent future bore wear. Due to the differences in thermal expansion rate of steel and aluminum, when the transmission approaches operating temperature the sleeve is allowed excessive clearance and scrubs the bore. The reverse boost valve spool lands have also been lengthened to aid in maintaining hydraulic integrity.

This large reverse boost valve assembly is made from hardened steel and prevents leakage at the valve.
