Article No.: TASC Tip\_05-07

## Make use of those mystery fixes

Here is a real-life story of a mystery part failure that came to visit our shop. We recently had a 2004 Pontiac Grand Prix with a 4T65-E and 74,000 miles come in with the filter stopped up. We scanned the vehicle to find a DTC P1811 (Maximum Adapts Exceeded) and a P0748 (Pressure Control Solenoid Circuit Error). Both codes were looked at by the tech doing the scanning as being corrected with a normal overhaul and a new pressure control solenoid (PCS).

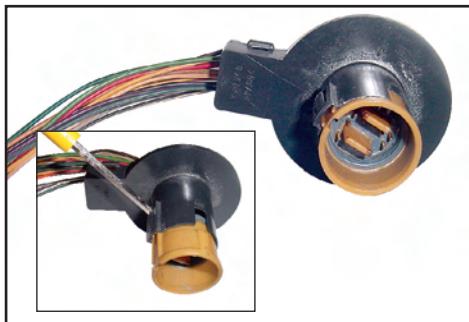
Figure 1

This harness is very similar to the proven 4L60-E/4L80-E harness that has been around a long time. It just doesn't give much trouble. As I sat there looking at that harness, I was wondering if we were going to have to start replacing all internal harnesses during an overhaul. This would require stocking several harnesses to accommodate the many different pressure switches and internal mode switches. These harnesses aren't cheap either, ranging from \$55 to \$75. With all this in mind I figured, what do I have to lose? I got out my pocket screwdriver, squinted my eyes at it with a Clint Eastwood glare, as if to tell the harness I'm going in, and started dissecting it. After removing the split loom and finding nothing wrong with the wiring, I took out the inside plastic sleeve that retains the wires secure in the case connector and there it was! It was full of corrosion and debris. None of this is visible without taking the connector apart (see Figure 1).

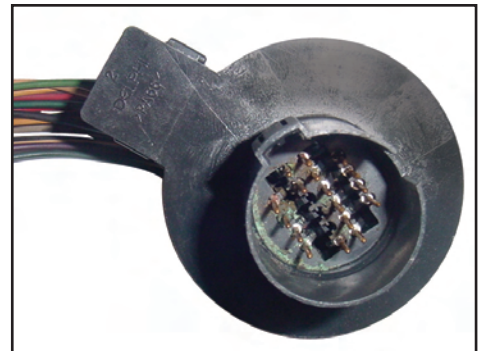
Figure 3

The debris and corrosion was shorting the terminals together inside the connector (see figures 2 and 3). It only takes about 30 seconds to pop the securing sleeve out and inspect the connectors. You can easily put it back together if you find nothing wrong with it. And of course I'm sure you can clean it and reuse it, but

Now I was thinking, what is the difference between the 4T65-E's connector and the 4L60-E/4L80-E? The 4L60-E/4L80-E harnesses are down low, away from the heated condensation that the 4T65-E has to endure, as the 4T65-E connector is near the vent. It is one of those cases where a familiar part placed in a

I would recommend replacing the harness if you find one as contaminated as badly as the one shown in Figures 2 and 3.

One thing for sure: We will be inspecting these connectors during an overhaul from now on – especially on transmission-transaxles that come in with circuit codes.
