**Article No.:** TCTIP-11-08

## CENTERLINE ISSUES: TCC FRICTIONS BONDED OFF CENTER

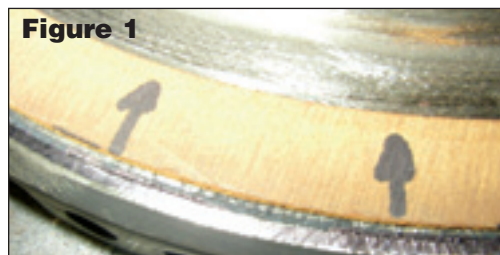
A closer inspection of the clutch showed a wider glue stain on one side suggesting that the friction material was being pushed to the side (**Figure 1**). Robert was now convinced that the problem was in the bonder. He allowed the bonder to cool down and then started his inspection. The first thing he looked at was the bonder plates. The bonder plates were tightened properly and the mating surfaces were parallel. He next turned his attention to the bonder dies and the piston ram. The dies were removed from the bonder, the ram was stroked to its downward most position, and the air pressure was released from the cylinder. At this point Robert discovered that there was almost

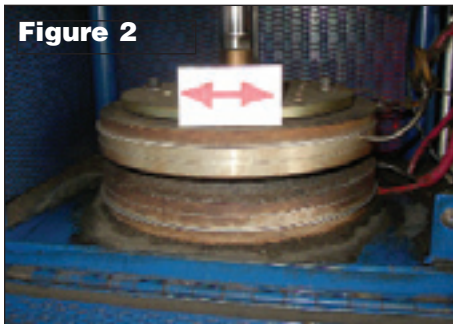
**Figure 2**

3/8" of side-to-side motion in the shaft of the ram (**Figure 2**). This movement was caused by a worn lower bushing. There are two important

things to note: 1) while there was air pressure in the cylinder, the piston held the shaft and no side-to-side motion could be felt, and 2) the air pressure remained on the up side of the piston so there was no tell-tale leak at the worn bushing. As the adhesive turned to a liquid (the flow zone) the friction material would slowly shift from left to right. A new cylinder was purchased from a local supplier and the off center problem went away.
