Article No.: TCTIP-07-2009

Change May Be Good But Be Careful

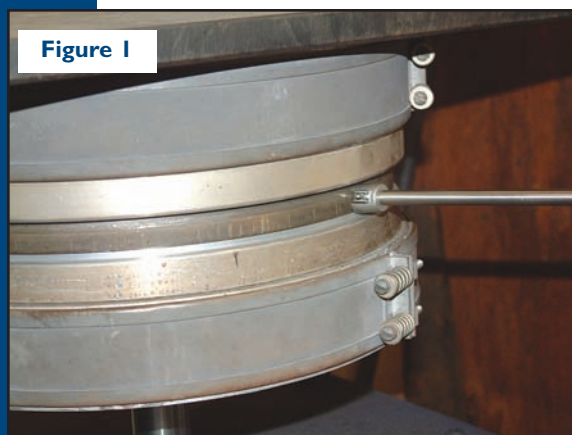
Figure 1

Checking the bond line temperature.

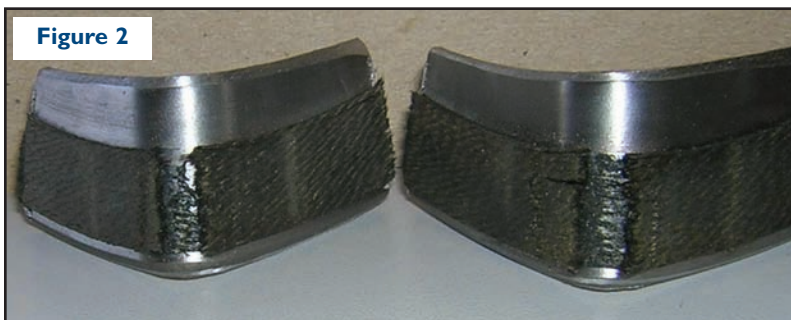
parameters. Besides not plotting the temperature curve, the rebuilder also did not do a bend test on the new friction material. A later failed bend test did show that there was very little transfer of adhesive from the friction material to the piston. (*Figure 2*) Doing the temperature curve or the bend test would have identified a potential problem and may have prevented the costly comebacks.

The left sample shows little adhesive remaining on the plate after a bend test, indicating poor adhesive transfer during bonding. Sample on the right shows an acceptable amount of adhesive remaining.

1. Never assume that your bonding set up will work after making a change, no matter how small or routine the change seems to be.
2. DO NOT short-cut the set up process! (This includes doing temperature curves and bend tests.)
