TECH ADVISORY

TORQUE CONVERTER

DECEMBER 2007

Installation of the Roller Clutch Outer Race in the BW-ST-I Stator

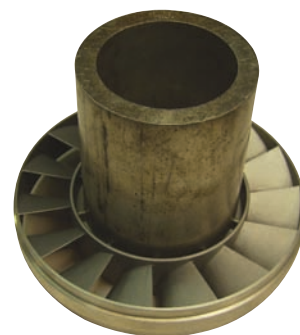
Figure 1

Correct alignment is critical for successful installation of the roller clutch outer race into the BW-ST-I stator, and proper fixturing is the key to correct alignment. The only area suitable for supporting the stator is directly below the roller clutch outer race. A piece of tubing will do a good job of supporting the stator, provided it is the correct size. The I.D. of the tubing cannot be any smaller than 3.50" or it will come into contact with the radius at the I.D. of the stator where the bearing rides. The O.D. of the tubing cannot be any larger than 4.50" or it will come into contact with the outside radius of the stator. Any tubing with I.D. and O.D. dimensions that remain within the 3.50" to 4.50" parameters will work. Do not try to support the stator on the bearing thrust area or on the outer O.D. because supporting the stator on either of these surfaces will distort the stator, making the installation more difficult (see Figures 1 and 2).
