Article No.: TC-TIP-09-08

Blame the Torque Converter - Part 1

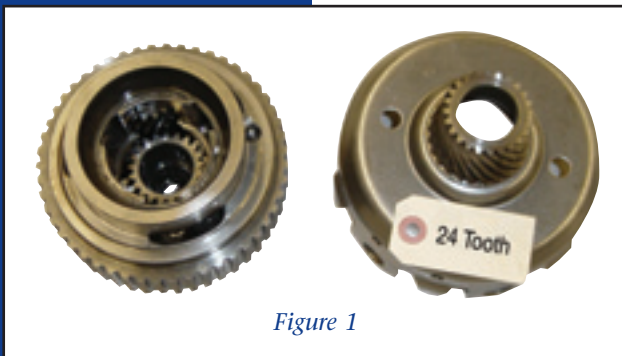
Figure 1

The transmission was also disassembled and thoroughly checked. The inside of the transmission appeared to be pristine. The transmission was reassembled and the valve body was replaced with a reman unit. The transmission was reinstalled into the vehicle and road tested, but after about 35 miles, the 740 code returned. The technician was convinced that the problem was inside the converter, so the converter was replaced with another reman unit. The 740 code returned on the next road test. The technician road tested the vehicle yet another time, but this time he did not allow the transmission to shift into the OD range. With OD inhibited the 740 code did not return. The technician began looking for an OD ratio difference. He found that during the first rebuild the original OD planetary with a 24 tooth sun gear (*Figure 1*) had been replaced with an OD planetary with a 27 tooth sun gear (*Figure 2*) and that turned out to be the problem.

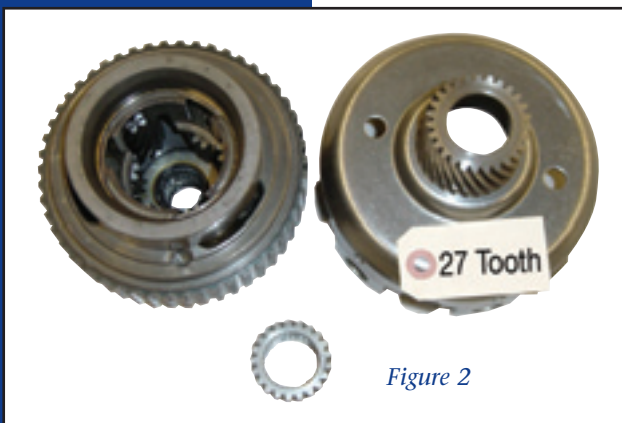
Figure 2

Prior to the original repair, the 740 code was being set when the computer commanded Overdrive and lockup and the transmission could not attain desired overdrive ratio because of the failed planetary. The second time around, the 740 code was being set because the overdrive ratio did not match what was expected. The converter was not the cause of the 740 code in either situation.

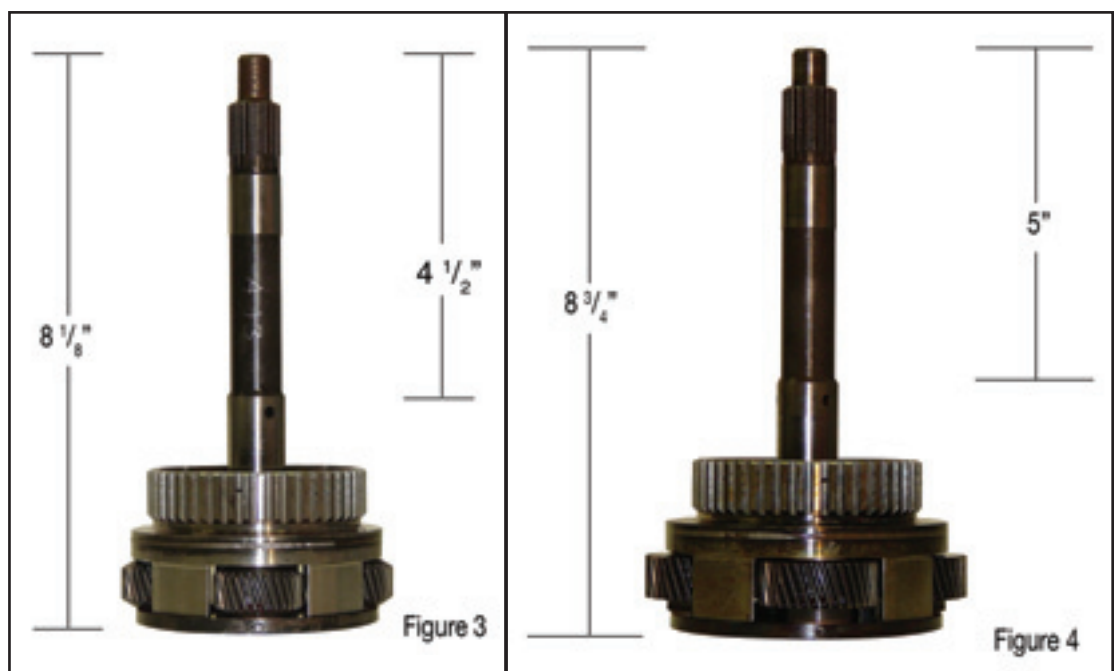
engine to stall when it was blocked in the apply mode, he reasoned that the TCC did not have enough clamping force (some type of internal leak). The converter was removed from the vehicle and returned to the converter shop. When Justin Kawasugi, the owner of the Kaslakua Converter Company, opened the converter there was nothing wrong inside. Justin knew that the OD planet had been replaced and also knew that the input shaft was an integral part of the OD planet. He decided to check the OD planet to see if there was some type of flow difference with the replacement input shaft. What Justin did find was that the replacement OD planetary was $\frac{1}{8}$ " shorter than the original. The tip of the input shaft was just making contact with the seal in the turbine hub; No wonder full clamping force could not be attained. Multiple ratios are not the only differences in the OD planets used in the 340 transmissions. Some ratios are also available in more than one length. The 4 cylinder OD planet measures $8\frac{1}{8}$ " long (Figure 3) and the V6 and V8 OD planets measure $8\frac{3}{4}$ " long (Figure 4).

In this situation, putting the 4 cylinder planetary into the V8 transmission had caused the problem. Once again, the converter was not to blame.
