Technical Bulletin

Don't be so S E N S I T I V E

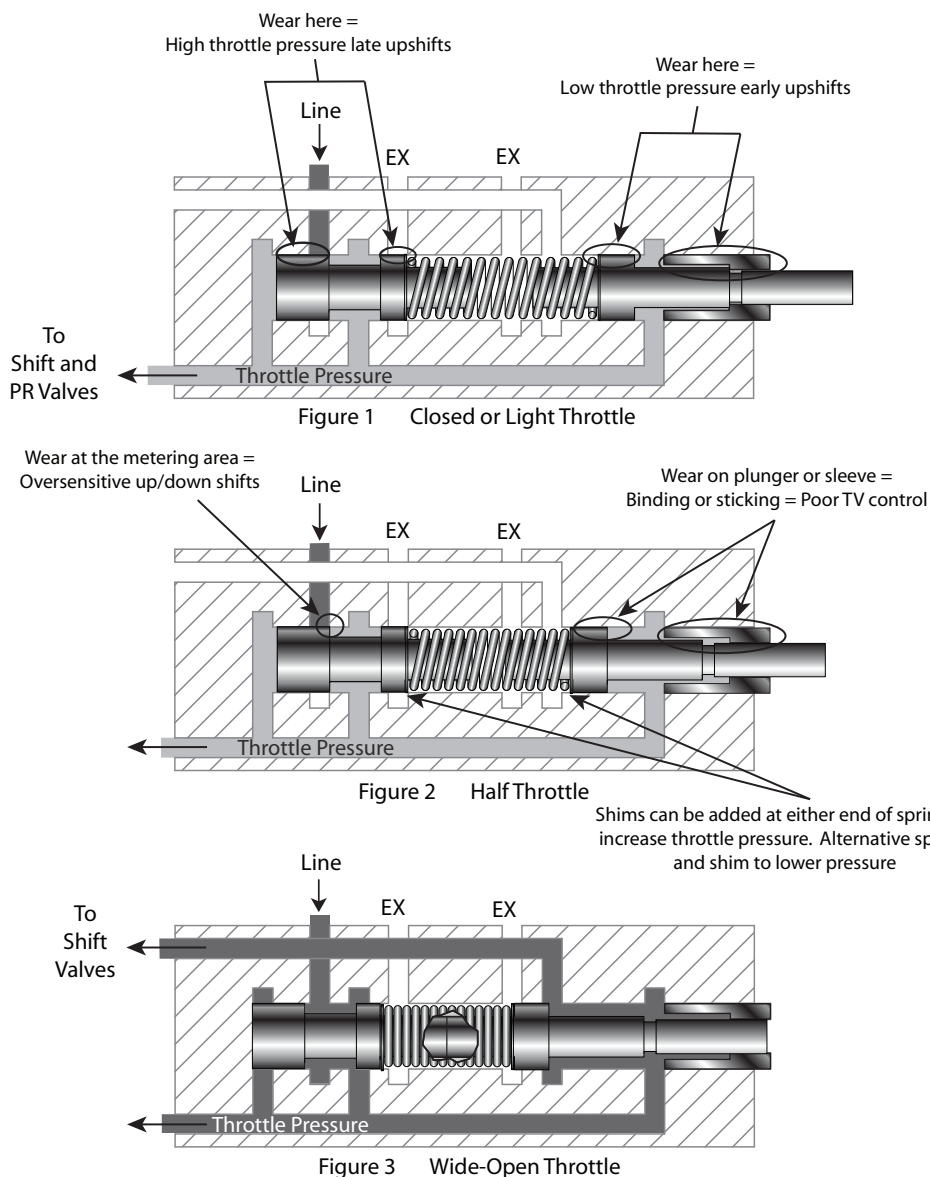
As seen in Figure 1, TV pressure on the balance end of the throttle valve has matched the force of its regulating spring and has closed off incoming line pressure. Bore or valve wear at this end of the TV line-up results in higher-than-intended TV pressure. This increase upsets the balance of power and results in late upshifts. A very critical area of concern is the valve spool and bore area, where the throttle valve meters or controls the ability of available line pressure to become throttle pressure (see Figure 2). The valve spends much of its life around this position so the wear is greatest at that point. Wear here can allow minor valve movement to have a greater effect on TV pressure changes than intended. The all-too-familiar oversensitive 3-2 and 2-3 shifts are often the result.

The righthand side of the TV line-up is the kickdown or plunger valve and sleeve. This is where actual throttle position gets to influence TV pressure. Figure 1 shows the kickdown valve at a closed or light throttle position. In Figure 2, at half-throttle position, the kickdown valve is held in, loading the spring against the throttle valve. This increased force from the spring side means more throttle pressure must build up on the balance side of the throttle valve before it regulates over and clips off incoming line. The valve and sleeve areas are a potential leak point for TV pressure, which would result in lower TV or early upshifts (see Figure 1). Side loading and mechanical wear can also result in binding or sticking of the plunger, which translates into restricted control over the throttle valve and the resulting throttle pressure (see Figure 2).

Increasing the amount to throttle input continues to exert more force on the spring side of the throttle valve with an increasing high throttle pressure resulting, to a point. At wide-open throttle (see Figure 3), the plunger valve tip can actually come fully against the throttle valve tip. With this mechanical hold in place the TV valve can no longer regulate against the spring. Throttle

pressure can now become equal to line pressure.

The following pages include information on throttle valve kits that allow you to repair any of the Chrysler units mentioned here. Standard size valves are available in an OEM ratio and a heavy-duty ratio for the RWD units when only valve wear is evident. When valve and bore wear are encountered, oversized valves are available for both the FWD and RWD units, with one common tool kit used to oversize valve body bores for either design. All kits come with an alternative TV spring and shims (see Figure 2) that will allow the builder to make minor increases or decreases to the standard TV pressures, when needed. Instructions provide guidelines for spring and shim use.
