Article No.: TASC-TIP-11-08

Chrysler RWD Valve Body Linkage Pivot Wear

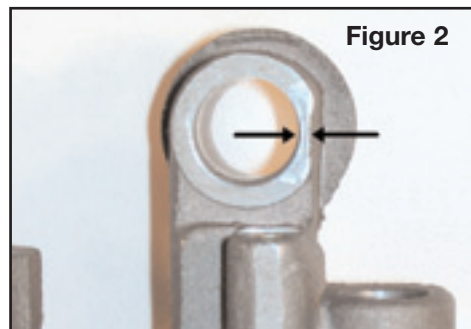
Figure 2

the lower pivot but typical bushings do not work well. The biggest problem is the flat on one side of the casting (Figure 2). If the bore is machined oversize to accept a typical bushing, the wall thickness of the bore ends up too thin and will crack. What follows is a method any shop can use: installing a very thin plastic Delrin® sleeve to salvage worn castings. Delrin® is a high strength, flexible, impact and abrasion resistant plastic material often used for bushings and thrust washers. The material used here is very reasonably priced. Items required for this repair include:

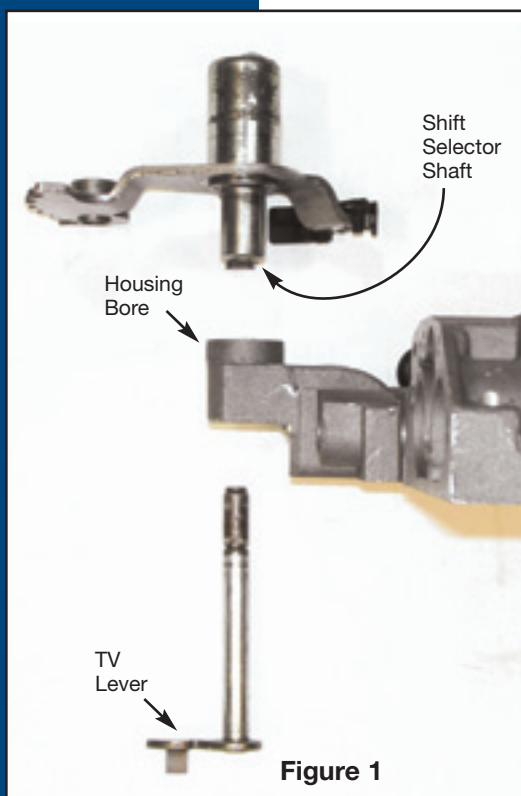
Figure 1

The basic design of the internal shift linkage of Chrysler / Dodge rear wheel drive transmissions has not changed since 1967 (Figure 1). As movement, vibration and wear take their toll over time, looseness of the internal linkage becomes a big problem. When there is excess

movement in the manual lever, the manual valve is not held precisely in position, resulting in fluid leakage, cross leaks and unit failure. Even a small amount of positional error becomes a problem on these units, due to the narrow width of the lands in these Chrysler valve bodies.
