Article No.: TASC-TIP-03-10

## A Fly on the Wall

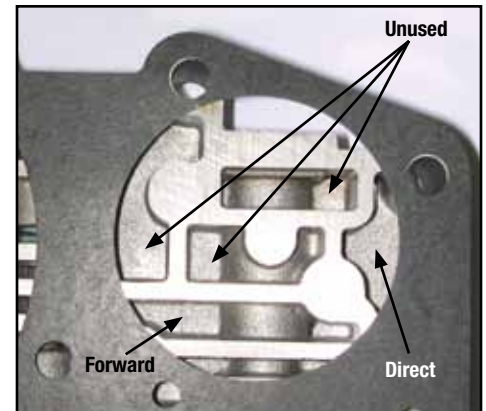
Figure 2

Direct clutch oil circuits are separate and, for the most part, kept isolated from each other except for one area. That area is in the casting under the separator plate, below the 2-3 accumulator (See *Figure 2*).

In the 2001 up units, there is no mechanical clamping of the separator plate and valve body gasket to maintain the seal between the forward and direct circuits. To confirm this on the next one you tear down, look at the imprint the valve body passages leave on the gasket. Lay the upper gasket over the lower gasket and look closely in the area of the 2-3 accumulator (the smaller of the three openings in the upper gasket). What you will see is a heavy imprint of the valve body castings across most of the lower gasket except in the area of the 2-3 accumulator. I cannot think of any other transmission where the separator plate/valve body gaskets have such a large gasket area that is not mechanically compressed.

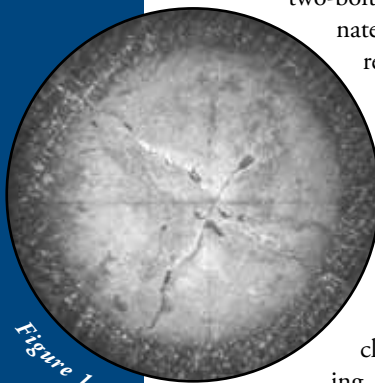
Figure 1

At first glance, you might assume that the cracks we see in the separator plate (see *Figure 1*) are caused by the 2-3 accumulator retainer’s rounded end smacking against the plate. You might also assume the cracks are a problem, but the cracks and the accumulator retainer seating directly on the separator plate are not the problem. The cracks are a symptom of a completely different and bigger problem related to the Forward and Direct clutch circuits.

Cracks in the plate may not look good, but dragging clutches is far more destructive. The problem is not with the separator plate. The problem is that the two-bolt retainer was eliminated.

The only absolute fix to prevent crossleaks between the Forward and Direct clutch circuits is to mechanically clamp the separator plate and gasket to the valve body with a two-bolt plate, like the earlier models. The bolt hole locations need to be drilled and tapped, and the separator plate bolt holes need to be drilled. The lower gasket can be used to locate the holes. If you have earlier valve body cores lying around, it is easy enough to take

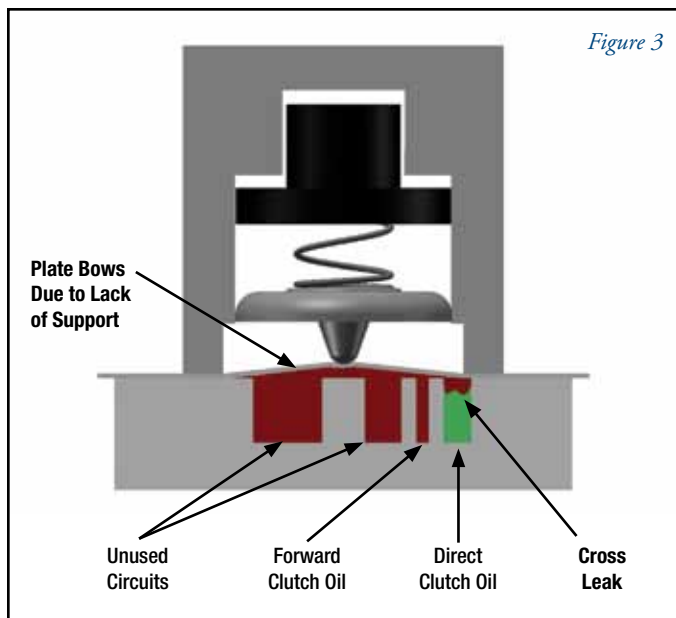
The biggest problem caused by eliminating the two-bolt plate is not cracked separator plates; rather, the biggest problem is cross leaks between the Forward and Direct clutch circuits. Without mechanical clamping of the gasket, pressurized oil seeps into the unused valve body passages and pushes upward on the separator plate, similar to how oil pushes on a servo. Figure 3 shows the unit when the Forward clutch is applied and Direct clutch is not applied.

When the plate bows upwards, the Forward clutch oil pressure bleeds over or cross leaks

into the direct clutch circuit. I have measured the plate bowing upwards as much as .011", with normal (forward) oil pressure.
