# THE TORQUE CONVERTER JOURNAL

VOLUME 4 NUMBER 1

## ALLISON 1000/2000/2400 CONVERTERS

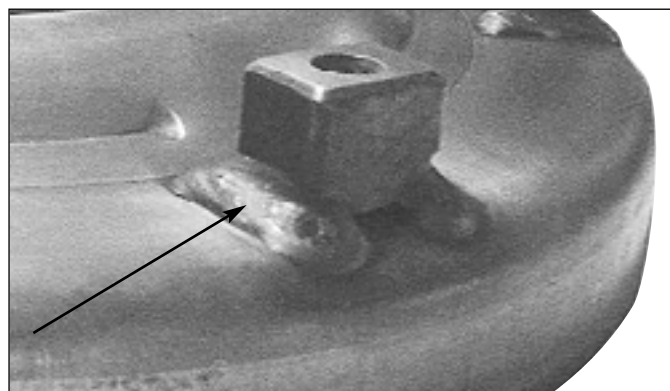
Figure 1

The luckier shops had the converter come in with a leak. In these cases the leak was found to be in a crack around one of the mounting pads and the converter was deemed unsalvageable (see Figure 1). Of course, the estimate given to the customer was off by the amount spent for the new factory converter. This led to an unhappy customer, but did not cost the shop any money.

Unluckier shops received the converter without a leak problem. In these cases the converter was rebuilt in the normal fashion, only to return in the near future with a warranty leak problem — a cracked cover at the pads. (This was especially problematic after the clutch surface was remachined.) The comeback became the problem of the converter shop and was very expensive. Even if the leak was caught before any damage was done to the transmission, the cost of the R&R and the replacement converter was substantial. To make things worse, the replacement converters weren't any better than the originals until model year 2006. For this reason, many shops decided

When Sonnax came out with the **AL-CC-1** and **AL-CC-2** billet covers, all of the leak problems went away. In addition, when LuK took over the manufacturing of the Allison 1000/2000/2400 converters in model year 2006, the OEM leak problems also went away.

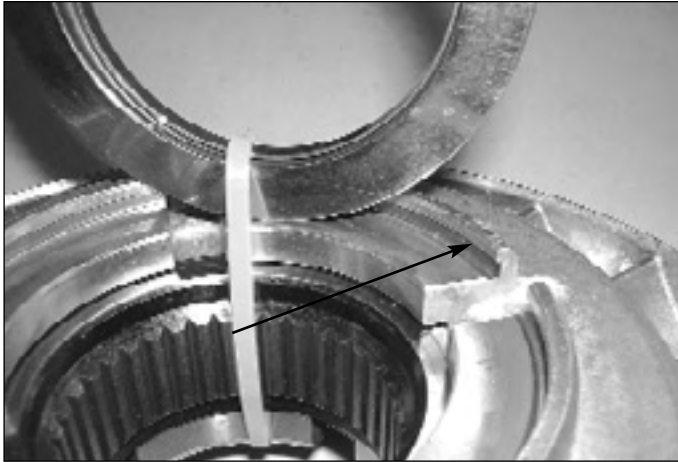
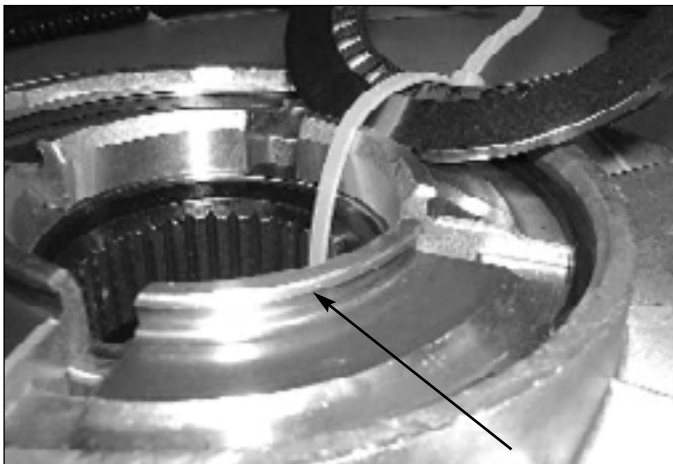
Unfortunately, this was not the end of problems with the early Allison 1000/2000/2400 converters. One problem was that there were no replacement bearings available. This seemed like a big enough problem, until the root cause of the bearing failures was finally diagnosed. The bearing failures were the result of the bearings running off of the centerline of the converter. The piloting area of both the stator and the stator cap were being worn by the bearing races (see Figures 2 and 3).

The Sonnax **AL-WS-1** or **AL-WS-3** (stator bearing spacer) and **AL-WA-2** (stator cap/bearing adapter) address all of the bearing issues of the early Allison 1000/2000/2400 converters. These parts make it possible to use the readily available **AL-N-1** and **AL-N-2** fully enclosed bearings that are used in the late-model Allison converters. These parts also address the wear issue by adding tangs to both the **AL-WS-1** (or alternate version, **AL-WS-3**) and **AL-WA-2** to prevent them from rotating against their mating parts.

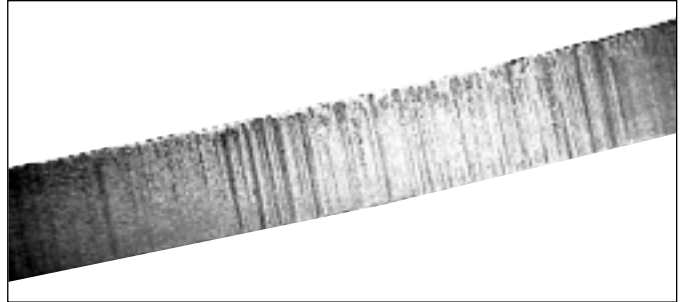
Figure 4

One reason for this wear is that the bearing races are separate from the bearings and are free to rotate on the stator and stator cap. Another reason for this wear is the lack of a machined surface on the I.D. and O.D. of the bearing races (see Figure 4). The I.D. and O.D. surfaces of the bearing races are similar to a water jet cut. This jagged edge reacts like a saw blade against the stator and stator cap.
