## COMPLAINT

## Reverse drum, retainer and planet failure

## Upgraded Piston Retainer

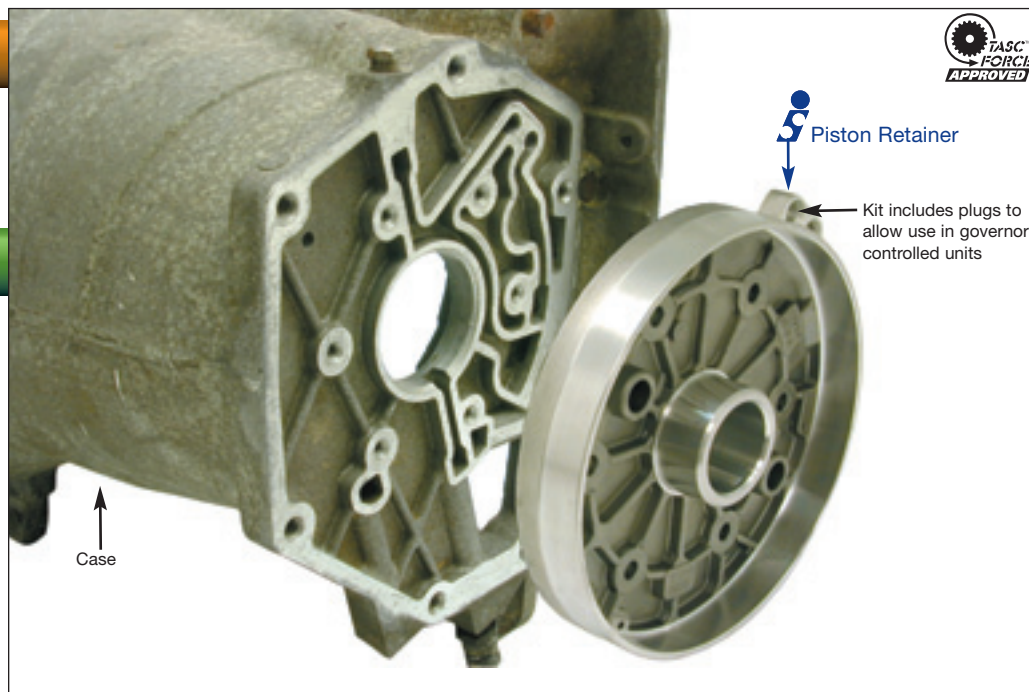
- Loss of lube oil to the gear train

Excessive clearance between the over-drive piston retainer and intermediate shaft reduces lube flow to the gear train.

Seal compensates for variations in case I.D. Oil is delivered to maximum load points on shaft. Optional oversized reverse drum journal allows salvage of reverse drum.

Allows damaged reverse drum to be machined and salvaged.

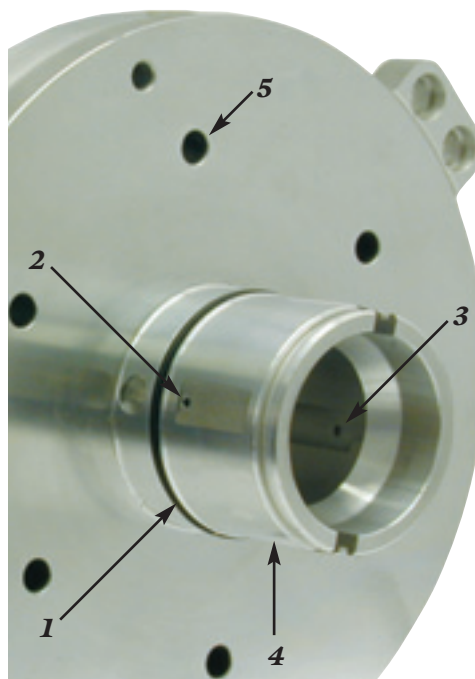
- 1 O-ring prevents loss of lube oil. Many OEM supports do not seal well in this area.
- 2 Two O.D. oil delivery grooves have been repositioned at high load areas.
- 3 Two I.D. oil delivery grooves run full length of load-bearing surface.
- 4 Band drum diameter (standard and oversized) allows drum I.D. to be turned.
- 5 High-quality aluminum resists gauling.
