## PREMATURE FAILURE OF MITSUBISHI GALANT RING GEARS

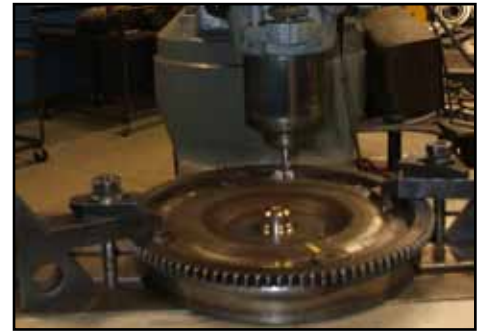
*The cover can be secured directly to the bed of a milling machine when removing only one ring gear.*

machining the welds off on a lathe. If you are only removing one ring gear, you can secure the cover directly to the bed of the milling machine, see below.

If you are removing more than one ring gear, you may want to mount your cover to a turntable. To remove the weld, plunge into the weld until the milling bit contacts the ring gear (the ring gear is harder than the weld and has a different feel on the cross feed). Do not force the milling bit into the ring gear. If you do, the bit will quickly become dull.
