Time to Change an Old Habit

By Ed Lee

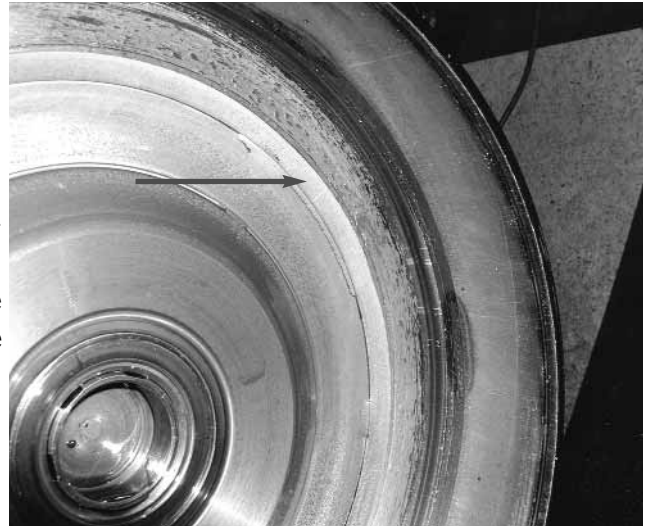
That's because any radius that remained after the resurfacing process would nibble away at the edge of the floater clutch when it applied over this radius. Eventually rebuilders did learn to pay attention to this detail, and since they learned how to machine that perfect 90° angle the hard way, it became a standard practice that has been carried on through the years. Nowadays it is no longer necessary to have the 90° angle machined on most covers, except to ensure proper clearance, and the habit that was learned to prevent one problem is now creating another.

Figure 1: That perfect 90° angle is seen here.

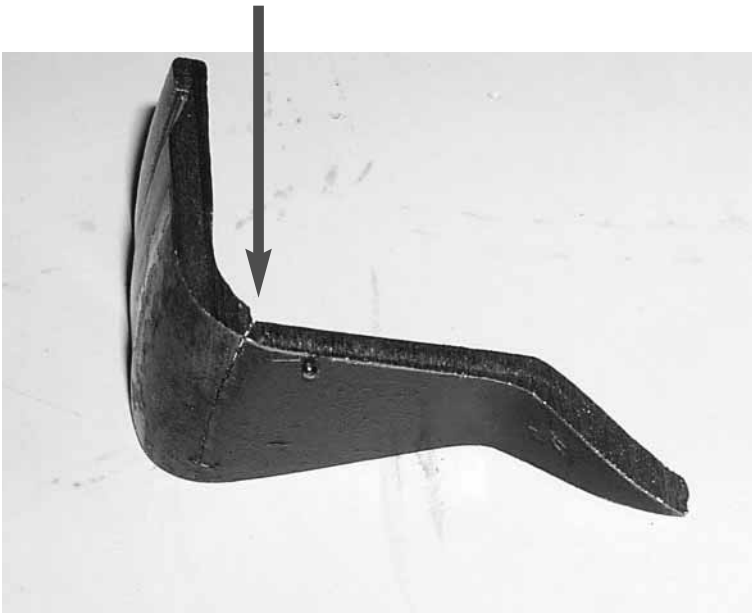
Our industry is reporting an increasing number of converter leaks that are coming from this area. The normal stresses that are being exerted on the converter during acceleration -- plus the extra stress of lock-up apply -- are causing the converter to flex. And the culprit is the sharp angle at the edge of the lockup surface, which creates a flex point for a crack to start.

Figure 2:
Machining has weakened the cover and created a flex point for a crack to start.

The crack in Figure 2 is on an A4LD converter. From the cut-away you can see why the cover is cracked. The cover was machined to about half of its original thickness at the point of the crack. This problem is also common on the E4OD and 4R100 converters. When the clutch surface of any cover needs remachining, consider the machining that has to be done for the clutch that you are using. Check the surface area of the cover that the friction material applies against. This area needs to have an apply finish of 10-20 RA.

Now set the piston onto the cover and check to see what areas have to be machined for proper clearance. Keep in mind that the piston is closer to the cover by the amount that you just machined off

the cover. Check closely for interference between the piston and cover, both inside and outside of the clutch apply surface. Remember that any material that you are removing is weakening the cover, so do not remove any more than necessary for clearance.

In the past, the outer edge of the apply surface was machined to reduce wear on the floater clutch, but now it is mostly done out of habit. Changing this habit will help to prevent some future leaks.
