COMPLAINT

Dipstick Tube Shield

92834-07

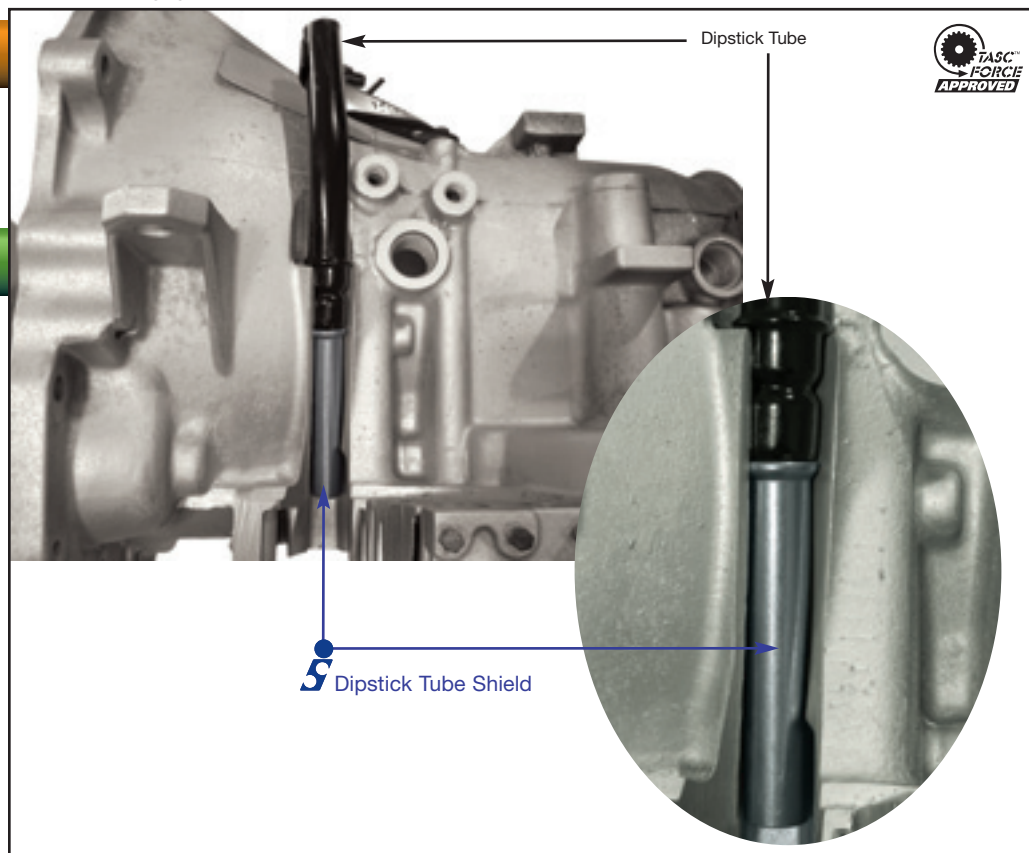
Dipstick reads full when unit is low on fluid

There is a slot in the case near the pump, and when transmission fluid level is low, fluid sprays onto the dipstick, giving the appearance of being full or overfull.

Install this dipstick tube shield into the dipstick tube hole prior to installing dipstick tube. When installed, the dipstick shield allows for consistent fluid level readings.

Sonnax dipstick tube shield 92834-07 prevents inconsistent dipstick readings caused by oil splashing onto the dipstick, and ensures correct fluid level for proper transmission operation. This part is intended to work with filler tubes that extend into case 1.125 inches. This will not work with late-style replacement filler tubes that extend into case 4.75 inches.

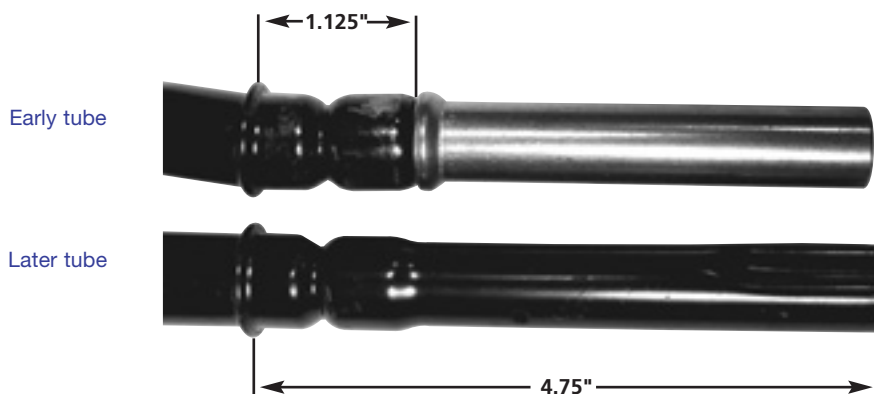
Caution: The Sonnax shield does not work with the longer 4.75" tube.
