Article No.: TC Tip_10-07

Torque converter forensics

Three preventable bearing failures

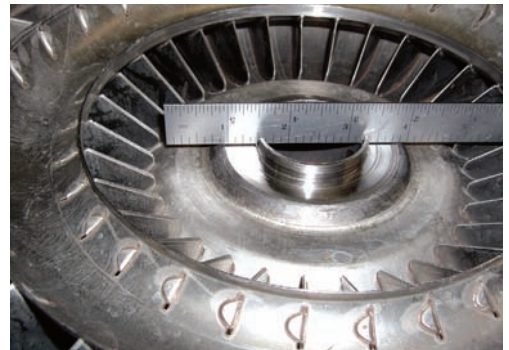
The bearing located between the impeller and stator was found to be defective. When the bearing was rotated by hand, a roughness could be felt, and when the bearing was taken apart, spalling could be seen. The bearing appeared to have been replaced during the recent overhaul, and the mating surfaces to the bearing also appeared to be prepared properly. The surfaces at the stator and impeller were both machined flat and were perpendicular to the center line of the converter. The only clue the converter rebuilder noticed was an uneven pattern on the tanged washer (spacer) located between the bearing and the impeller. During the recent rebuild the surface on the impeller where the bearing rides was prepared correctly, but the grooves that retain the washers tangs (keeping

the washer from rotating) were not deepened to the level of the newly machined surface. The tangs of the washer bottomed in the grooves and never allowed the washer to come into contact with the machined surface of the impeller (see Figures 1 and 2).

Figure 1: The 6-inch ruler is resting on the groove in the impeller. The gap under the ruler shows the distance between the washer and the surface it should be resting against.

This two-point contact allowed the washer to deflect, giving it the uneven wear pattern and causing the bearing to fail. When the bearing is supported by an uneven surface, the load that the bearing is carrying is not distributed evenly to the load-bearing elements of the bearing. When the grooves were machined to the proper depth, both the overall height and the endplay of the converter had to be adjusted.

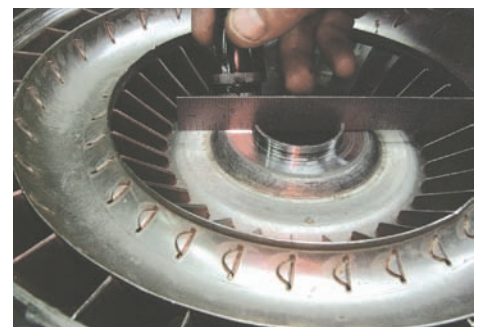
Figure 2: Highlighting the gap.

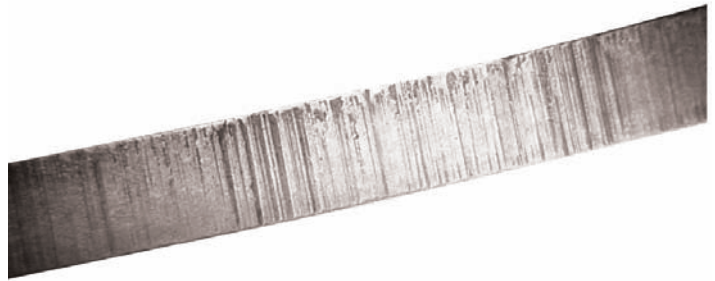
Figures 4 and 5 show how the wear to the piloting areas look. What appears to be snap ring grooves are the actual wear areas. The wear to the stator cap on the turbine side of the stator and the wear to the stator on the impeller side are almost equal, but the bearing on the impeller side failed first, because it carries more load. The reason for this wear is twofold: First, the races are separate from the bearings and are free to rotate on the stator and stator cap, and second, the I.D. and O.D. of the races are not machined surfaces. The magnified picture in Figure 6 shows this area. The uneven surface is why the wear is so extreme. This bearing problem went away in model

Figure 6: A close-up of the bearing race O.D.

year 2006 when the bearings were redesigned as fully enclosed bearings instead of a bearing and separate race.
