Article No.: TC Tip_04-07

Lockup surge in Allison 1000s

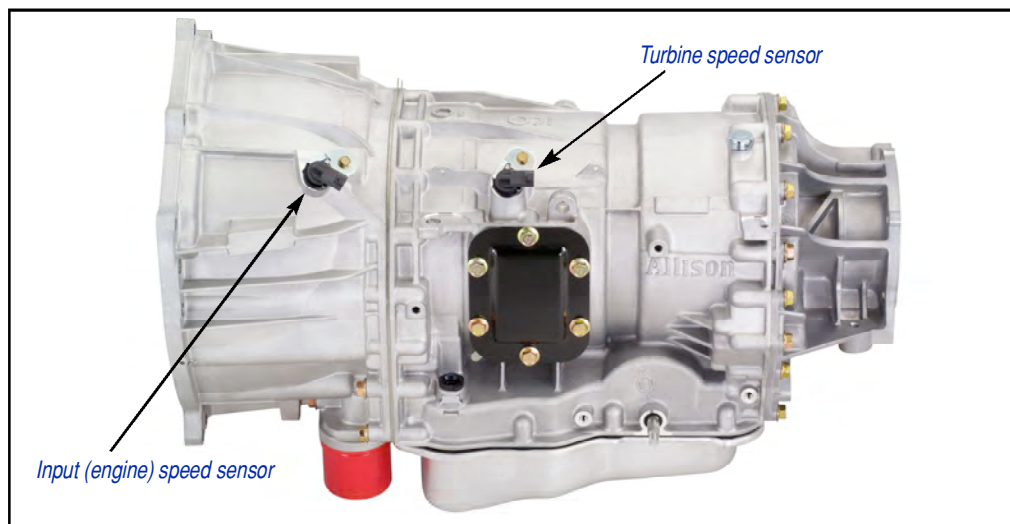
Figure 1

Here’s a case in point. A 2001 2WD Chevrolet 1500 with a 6.6L diesel engine and an Allison 1000 transmission was returned to a transmission shop. The transmission had been overhauled recently and the customer’s complaint was a cycling TCC, or what he described as a lockup surge. A scan check of the vehicle found no codes. The PCM would command the TCC solenoid off at regular intervals. The vehicle’s tachometer remained steady, but the live data on the scan tool showed a small repeating spike in the engine rpm. The pickup for the engine rpm sensor is the input speed sensor located in the bell housing of the transmission and is excited by the row of dimples on the torque converter closest to the engine.

It turned out that one of the dimples **on the outside of the converter** was partially flattened by a handling mishap and was causing the rpm glitch. Replacing the converter fixed the problem.

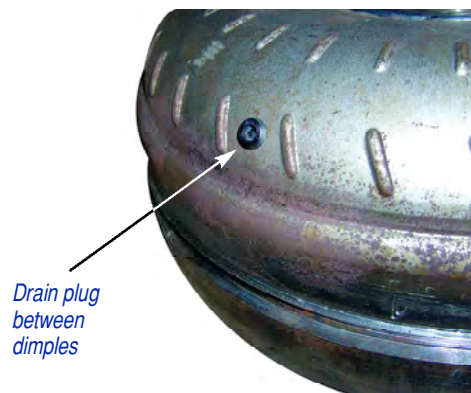
Figure 2

In a similar incident, a 2001 Chevrolet 2500HD pickup was returned to a transmission shop with the same lockup surge complaint. Again, there were no codes. The PCM would command the PWM solenoid to ramp up to about 60% and then would turn the TCC solenoid off. It would then repeat the cycle. A movie snapshot of the engine rpm showed an evenly spaced 150 rpm spike. On this vehicle, the engine rpm glitch was caused by a drain

plug that the converter rebuilder had added between two of the dimples in the row of exciter dimples.
