Article No.: TCTIP-03-10

More Torque Converter Forensics 4L80-E Overheating/740 Codes

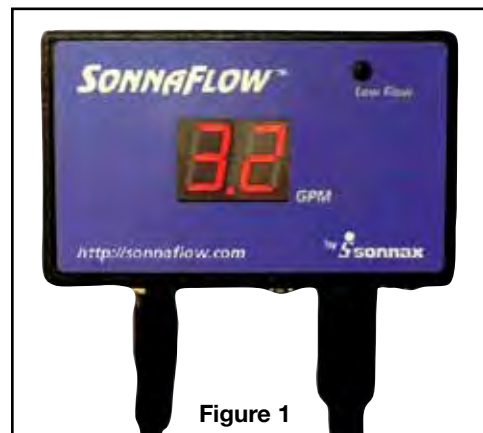
Figure 1

Vehicle #1 was a 1992 GM 3500 4 x 4 equipped with a utility body. The vehicle would not move forward and was towed to the shop. Upon tear down, the forward clutches were found to be completely burned up, and a complete overhaul including a rebuilt torque converter was recommended. The customer approved the overhaul and requested a temperature gauge be installed at the same time. The repair seemed to be progressing routinely until the R&R technician noticed that the temperature gauge had climbed to 190°F while the vehicle was still on the lift. At first the gauge was thought to be defective, but a replacement gauge showed the same temperature. The technician suspected a restricted cooler and a flow monitoring device was installed before the vehicle was road tested. On the shop's usual 6-mile test loop, the vehicle had a good cooler flow rate of 3.2 gallons per minute (G.P.M.), but reached transmission temperatures in excess of 285°F. (**Figure 1**).

The only time the temperature would go down was on a downhill coast, but that was only a 15 to 20 degree drop. The technician even burned his hand when he was removing the flow monitoring device. After an external cooler was added, the temperature was about 20°F cooler, but

was still considered excessive at 265°F. At this point the converter was removed for evaluation.

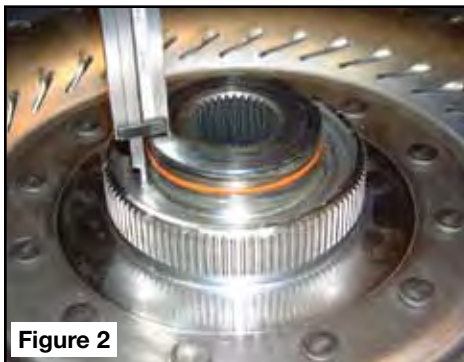
converters were cut apart. The overall height was correct for all three converters, and although the end play was on the high side at .025" (normal is .005" to .010"), it was not off enough to raise any red flags. When the converters were cut apart, the internal clearances and clutch release clearances were checked. The internal clearance was well within the proper parameters (.100" to .110"), but the clutch release clearance for the first converter was zero and the other two converters were at minus .005". Normal release clearance is .030" to .035".

How is a "negative clearance" possible? In this design, a clutch release clearance target of .030" to .035" (the piston travel from full apply to full release) is adjusted separately from the end-play. Clutch release clearance is calculated based on two dimensions. Dimension A is the distance between the leading edge of the turbine hub and the surface the piston will rest on when it is in the fully released position. **See Figure 2.**

What caused the zero and negative clearances in the three converters? All three converters originally had .040" friction material, and all were rebuilt using .075" friction material during the rebond process. The .035" difference in the thickness of the friction material caused the loss of clutch clearance. One way to resolve the clearance issue would have been to machine .035" from the reaction surface of the cover. For the three vehicles discussed here, the issue was resolved by returning to the original .040" thickness friction material.

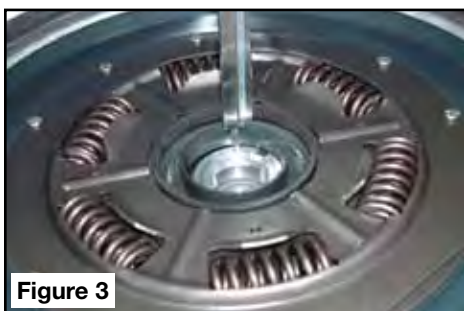
Dimension B is the distance between the lock up piston seal bore edge and the front thrust washer. **See Figure 3.**

This represents the piston's location in the fully applied position. Clutch release

clearance is the difference between the two measurements, or A minus B. If B is larger than A, then the negative number is "negative clearance". There is no clutch release clearance at all and the negative dimension is actually how far the turbine hub is being held back from its normal position of contacting the cover.
