Article No.: TASC-TIP-12-08

Toyota U140/U240 Series Diagnostic Information

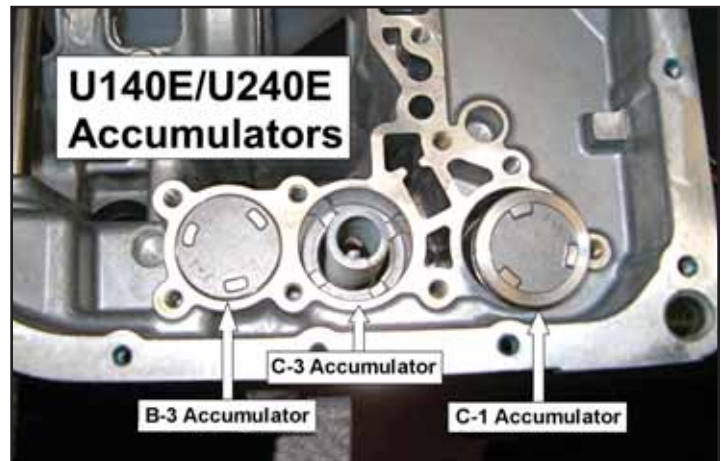
Case accumulator location

Various shift and engagement feel concerns can be due to accumulator spring mix up. The chart below shows the location, color and dimensions of each accumulator spring in the case.

- The C1 accumulator is for neutral to drive engagement feel.
- The C3 accumulator is for the 3-4 shift feel.
- The B3 accumulator will affect the 4-3 downshift feel.
