4L30-E

Slips in 2nd or Slips in 3rd

Possible Converter Slip Code or Possibly Multiple Ratio Codes

By ED LEE

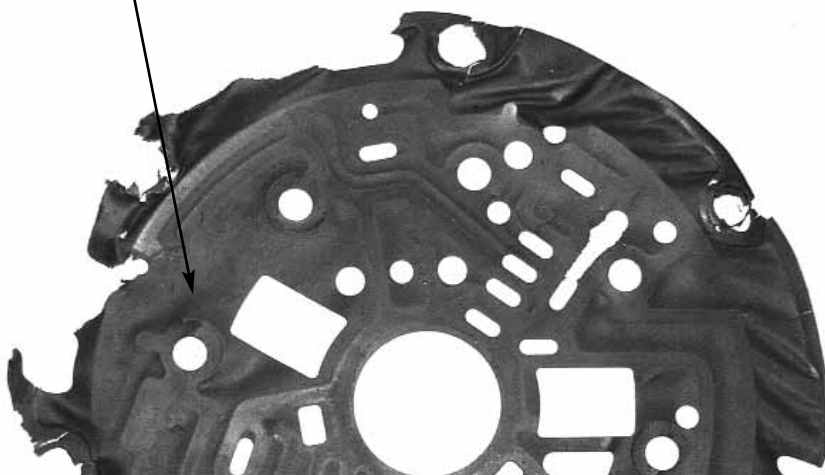
Figure 1

The distortion in the gaskets (See figures 1 and 2) led the technician to believe that some type of additive had been added to the transmission that had caused the gaskets to distort.

Distorted Area

Unfortunately, the original equipment (OE) gaskets in the 4L30-E transmission have a coefficient of friction low enough that it is almost impossible for the long retaining bolts to put enough force on the joint to keep it from sliding. When sliding occurs at the joint between the mating surfaces and the gaskets, it is only a matter of time before the gasket starts to move around in the joint. The sliding surfaces typically tear the gaskets, causing them to work their way out of the edges of the joint, or into the cavities within the joint (see figures 1 and 2).

Technicians with an “it has to be OE” philosophy need to pay close attention. The replacement gaskets provided by Interface Solutions Inc. the aftermarket manufacturer are slightly thicker than the OE gaskets (.015”) but they are more compressible and have a higher surface friction. The thicker, more compressible material spreads the bolt load out better and creates a larger effective contact area for friction to hold the parts together. This will keep the members of the joint from sliding.
