A Fix for 5R55W Front Planet Bearing Failure

By Ed Lee

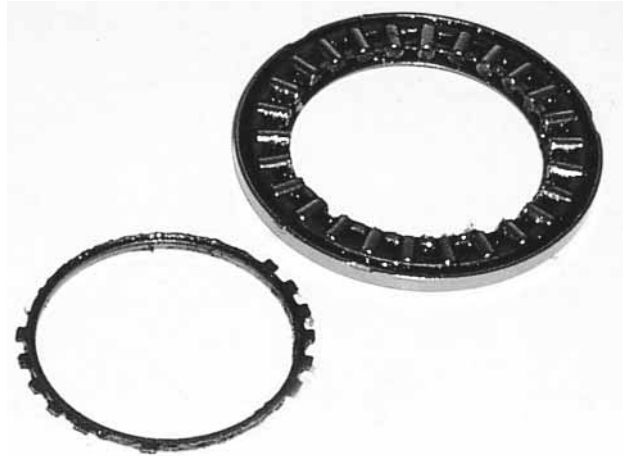
The problem with the 5R55W was that the center of the bearing cage on the sun gear side of the bearing would get stamped out, and this would eventually lead to catastrophic failure. In this event, replacement is the only option, and the replacement part is available from Ford (p/n 2L2Z-7A398-AA) for a couple hundred dollars. The original bearing is not available separately from the dealer and even if it were, it could not be replaced without disassembling the planet.

Figure 1:
The center of the bearing cage on the sun gear side of the bearing in a 5R55W can get stamped out, leading to catastrophic failure.

gear that mated to the opposite race. Provided that the planet side race is serviceable, you may substitute another bearing in the original planet. In this case, the bearing that rests between the stator support and the direct drum in the RE4F02A transmissions is a good choice.

The O.D. of this bearing provides a good fit in the sun gear, and the I.D. has sufficient clearance. The replacement bearing is .020" thinner than the original bearing, but this is not a problem. The aftermarket replacement shim for adjusting the front endplay on 700 -R4 and 4L60-E transmissions is made to order for this job. The shims are available in thicknesses of .010" (Sonnax p/n 77406-10) and .015"

(Sonnax p/n 77409-15). Place the appropriate shim between the sun gear and the bearing, and you're back in business.

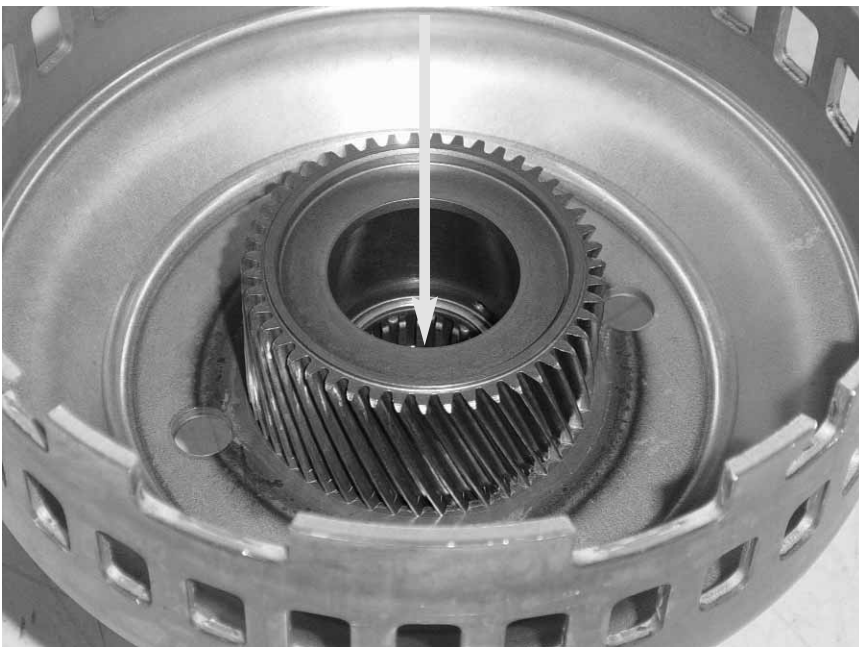
Figure 2:
The arrow shows the recess in the gear where the RE402A bearing fits.
