# RL4F02A/RE4F02A Mysterious Axle Seal Leak

By Ed Lee

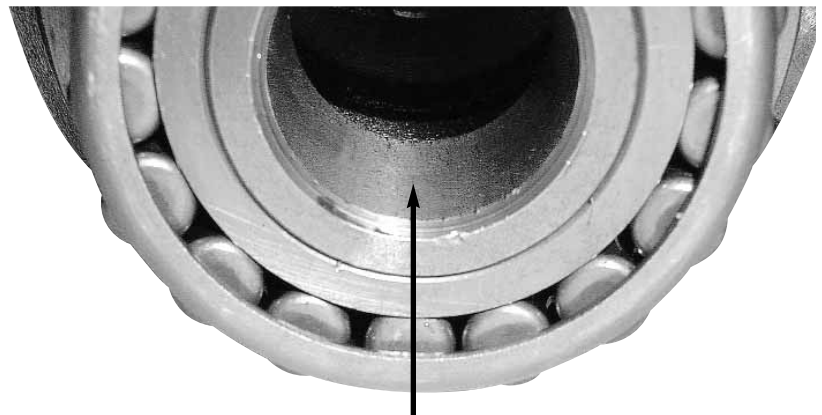
Figure 1

The technician who was working on the vehicle confirmed that the passenger side axle seal and axle had been replaced recently, and that ATF was dripping from the seal. The technician checked for side-to-side movement of the axle where it contacts the seal. His opinion was that play was present but not excessive. He also reasoned that the play was about the same as on the driver's side axle, which was not leaking. He pulled the axle out and removed the seal to inspect the differential carrier. The technician then exerted force on the carrier to make sure there was no play where the carrier was supported in the case. The carrier had no movement and the I.D. of the carrier, where the axle passes through, looked like new (see Figure 1).

Luckily, the pristine appearance of the I.D. of the carrier raised a red flag for the technician. He considered whether the shop that did the original overhaul had replaced the differential with the wrong one – or one with an I.D. that was bigger than the O.D. of the axle. A check of the differential proved that it was the correct one for the vehicle and that the I.D. was the correct dimension. When the axle was measured where it contacts the differential, it was .070" smaller than the I.D. of the carrier. This led the technician to consider a second scenario: whether the axle had been replaced with the wrong axle or at least with one that was smaller on the O.D. where it centered in the differential carrier. However, when the axle was checked out, it was the correct one for the vehicle and the O.D. dimension was correct for the axle.

The I.D. of the carrier looks brand-new.

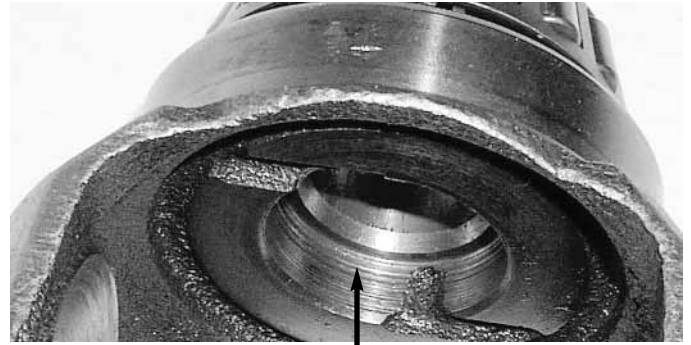
Figure 2

That left the question of how the axle was being centered in the seal. The passenger side axle on this model transmission is a two-piece axle. The inner section of the stub shaft is supported by a pillow-block bearing that is mounted to the side of the engine. Unlike a one-piece axle, the stub shaft does not have a constant velocity (CV) joint at the transmission end. The side gear that the axle is splined into is the only thing that centers the axle. The clearance between the side gear and the carrier must have been more than the seal could tolerate. But why didn't

The surface area that centers the side gear is worn out.

Remember: Don't be fooled by the pristine appearance of the differentials in RL4F02A/RE4F02A units and be sure to check them by prying on the side gears perpendicular to the cross shaft.

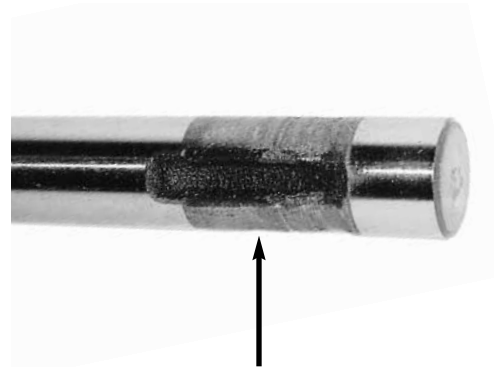
Figure 3

In one position, the spider gears that rotate on the cross shaft in the differential will support the side gear that drives the axle. If you pry on the axle on a plane that is parallel to the cross shaft, the axle will always appear tight. If you pry on the axle in any other position, the wear will show. The technician put the axle back into the differential and pushed it side to side on a plane that was perpendicular to the cross shaft. It had about .070" play (much more than the seal will tolerate). When the differential was removed from the transmission and taken apart, the wear was obvious (see Figure 2). At one time, one of the front wheels had been spinning faster than the other. You could tell this because of the galling on the cross shaft (see Figure 3). The vehicle was probably either stuck or accelerated while on a lift.

The shaft is galled where the spider gear rides. The vehicle was probably stuck with one wheel spinning.
