Mercedes 722.6: Cold Stall/Shudder Part II

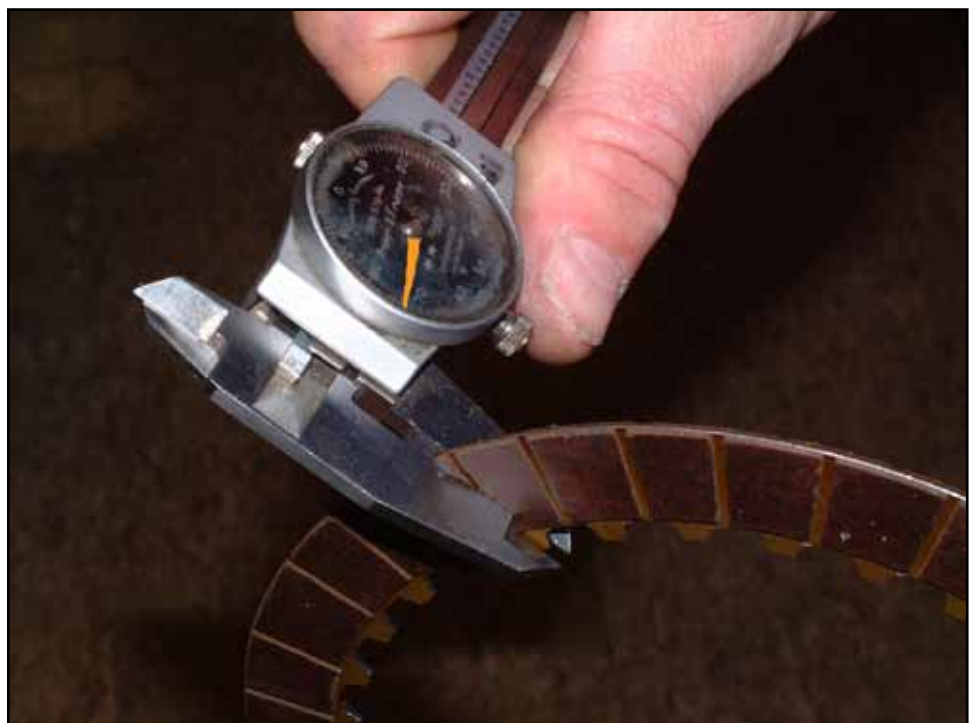
Figure 1

When the converter was inspected, excessive wear was found on the TCC frictions. The clutches did not visibly show the wear, but on the frictions it measured as much as .040" per clutch. (**Figure 1**)
