4T65E All Wheel Drive Problems

Noise and Gear Failures

By Ed Lee

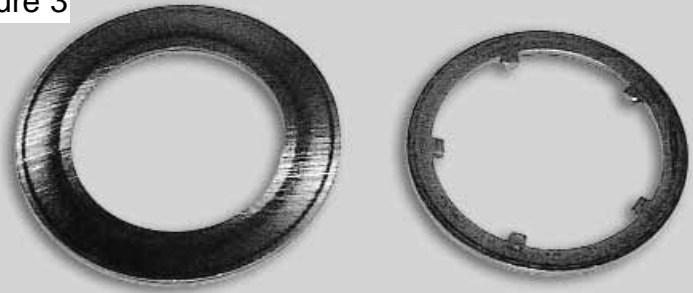
Figure 3

end play between .020" and .024". The selective thrust washers for the all-wheel-drive transaxles do not have a full circle I.D. like the front-wheel-drive washers.

Front and all-wheel-drive selective thrust washers.

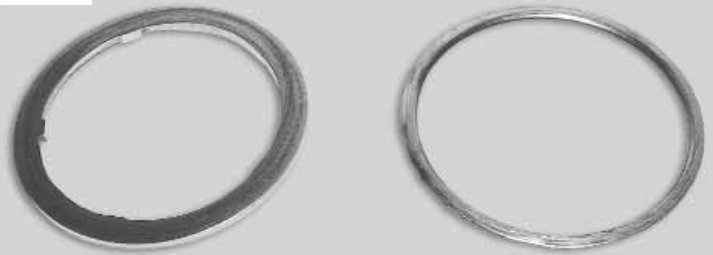
Figure 4

The five locating tabs on the all-wheel-drive washers only center the washers on the sun gear shaft. The washers are free to rotate on the shaft, and since the shaft is considerably harder than the washers, they wear quickly. The material that the shaft removes from the washers passes through the gears of the differential and causes damage similar to that seen in Figure 1. At this point, replacing the selective washer with an OE replacement is your only option.

Selective thrust washers showing signs of wear.

However, if you are really lucky, you may find a front-wheel-drive parking gear that is the same thickness as the combined thicknesses of the selective washer and the all-wheel-drive park gear. Another alternative is to find a front-wheel-drive park gear that is thicker than the washer and gears combined and have it machined to the proper thickness. Either way will work, and you will be safer than using the OE washer.
