THE TORQUE CONVERTER JOURNAL

Volume 4 Number 3

BLAME THE TORQUE CONVERTER

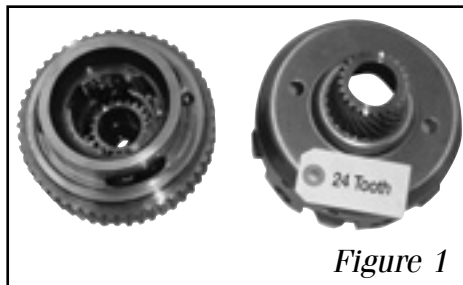
Figure 1

OD range. With OD inhibited the 740 code did not return. The technician began looking for an OD ratio difference. He found that during the first rebuild the original OD planetary with a 24 tooth sun gear (**Figure 1**) had been replaced with an OD planetary with a 27 tooth sun gear (**Figure 2**) and that turned out to be the problem.

Prior to the original repair, the 740 code was being set when the computer commanded Overdrive and lockup, but the transmission could not attain desired overdrive ratio because of the failed planetary. The second time around, the 740 code was being set because the overdrive ratio did not match what was expected. The converter was not the cause of the 740 code in either situation.

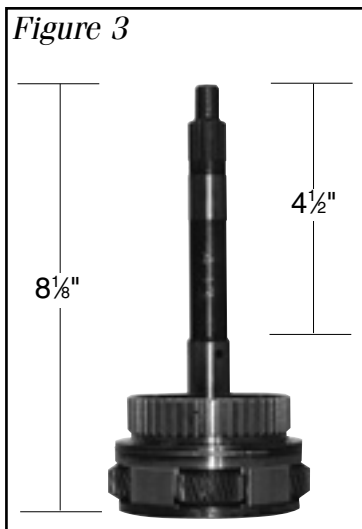
shaft was an integral part of the OD planet. He decided to check the OD planet to see if there was some type of flow difference with the replacement input shaft. What he found was that the replacement OD planetary was $\frac{1}{8}$ " shorter than the original. The tip of the input shaft was just making contact with the seal in the turbine hub. No wonder full clamping force could not be attained. Multiple ratios are not the only differences in the OD planets used in the 340 transmissions. Some ratios are also available in more than one length. The 4 cylinder OD planet measures $8\frac{1}{8}$ " long (**Figure 3**) and the V6 and V8 OD

In this situation, putting the 4 cylinder planetary into the V8 transmission had caused the problem. Once again, the converter was not to blame.

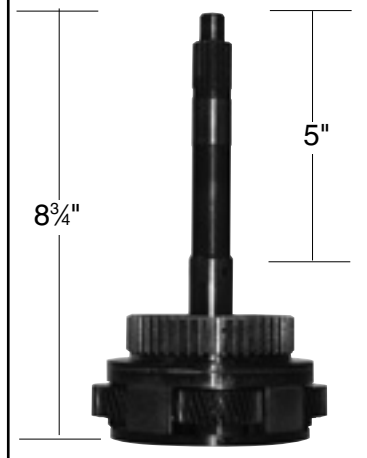
Figure 4

planets measure 8 $\frac{3}{4}$ " long (**Figure 4**).

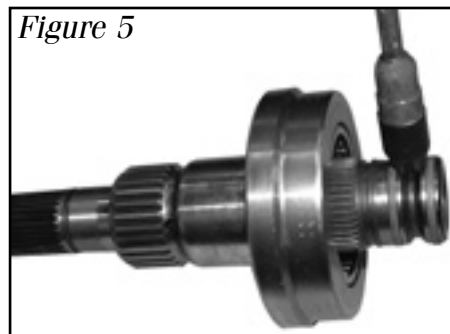
Mike Souza from ATSG wrote a great article (Transmission Digest April 2008) explaining this problem. The technician used the article as a reference to prove that this was causing the P0741 code, but when he applied air pressure to the TCC apply port on the 4T65-E turbine shaft (**Figure 5**), he got a full stream of air out

of the TCC apply port on the 4T60-E drive sprocket support. At that point he was no longer sure that he had found the problem.

There is enough clearance between the 4T60-E drive sprocket support and the 4T65-E turbine shaft to allow enough flow to pass an air check. The customer did not drive in any hilly areas and did not carry any passengers, so the lockup apply pressure

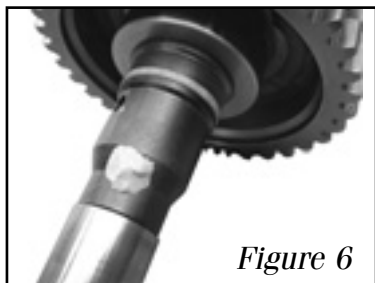
Figure 6

The figures illustrate the flow area difference created by the two different supports. **Figure 6** shows a small amount of plumbers putty placed on the 4T65-E turbine shaft before it was inserted into a 4T60-E drive sprocket support. The putty is being used like Plastigauge® to visually demonstrate the different clearances. **Figure 7** shows the putty compressed or removed by the support.

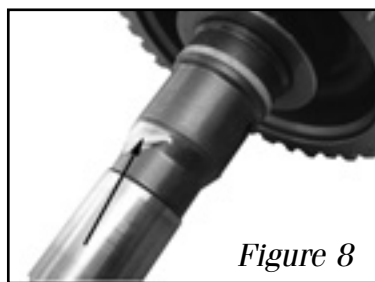
Figure 8

Notice how much more putty remains after the same shaft with new putty was inserted into the 4T65-E support (**Figure 8**).

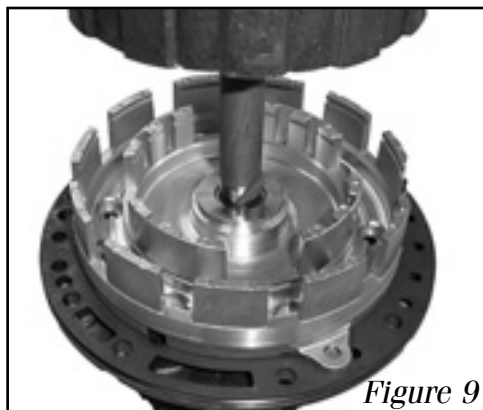
Figure 9 shows a piece of gasket material fitted into the overly large clearance that results when a small shaft is used in the large pump bushing.
