COMPLAINT

AW Boost Valve & Sleeve Kits

Sonnax Part Summary

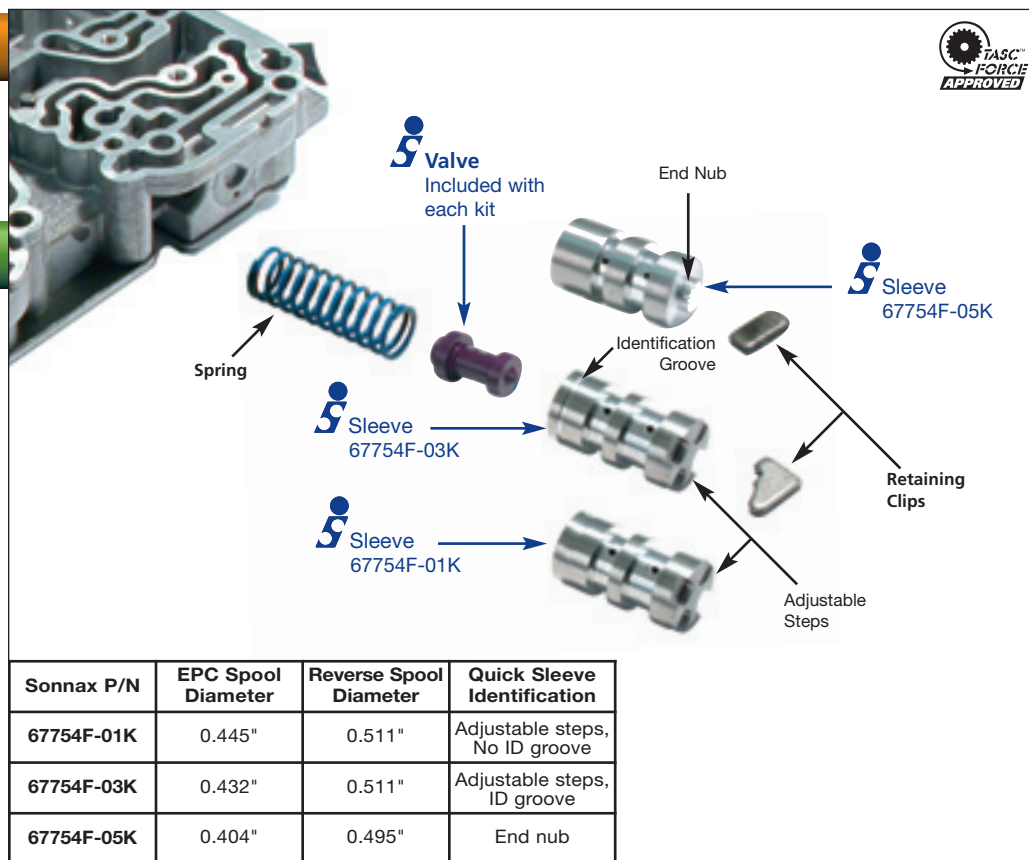
Continuous boost valve oscillation causes bore wear at the boost sleeve and allows EPC and/or reverse pressures to exhaust or cross leak.

Continuous oscillation of the OEM steel boost valve within the cast-aluminum sleeve causes bore wear at the boost sleeve and allows EPC and/or reverse pressures to exhaust or cross leak. Also, due to the differences in thermal expansion rates of steel and aluminum, as the vehicle reaches operating temperature, the clearance between the sleeve and valve may actually double and create a greater path for leakage. Sonnax now offers three replacement boost valve assemblies with upgraded materials to prevent future wear and reduce leakage due to thermal expansion.

These three replacement boost valve assemblies with upgraded materials will prevent future wear and reduce leakage due to thermal expansion.
