Article No.: TASC Tip_04-07

Catching a brake on shift problems

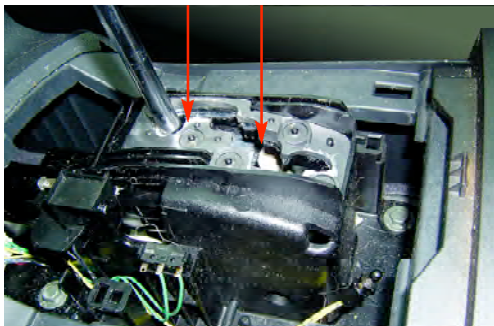
The foreman returned the vehicle to the shop and removed the top of the console to inspect the shifter interlock mechanism. There are two white plastic arms that move into position to block the park and neutral gates when the interlock is activated.

Figure 1: Interlock activated.

The shifter interlock is activated any time the ignition switch is in the "on" position and the vehicle is stopped or moving slower than 4 mph and the brake pedal is **NOT** depressed. This guarantees that the shifter cannot be moved to the reverse or drive positions without the driver having his or her foot on the brake pedal. After the vehicle reaches a speed of 4 mph or greater, the interlock system automatically engages and remains engaged, regardless of whether the brake pedal is depressed or not. This feature

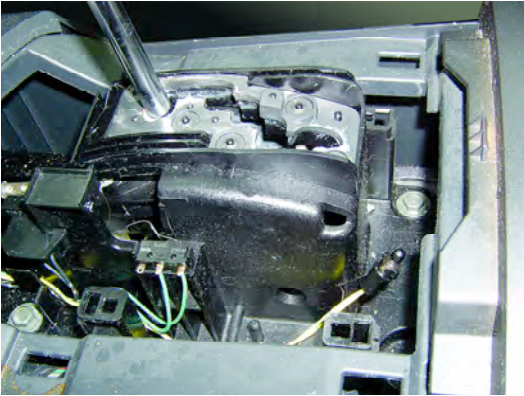
Figure 2: Interlock not activated.

guarantees that the vehicle shifter cannot be moved to the reverse position while the vehicle is moving faster than 4 mph. The brake switch was found to be defective, and replacing it fixed the shifter problem. The alarming thing was that the driver was unaware that her brake lights were not working on occasion. It was fortunate that the issue with the shifter exposed the brake light problem before it caused a rear-end collision.
