Article No.: TC Tip_EL_01-07

Converter charge mysteries

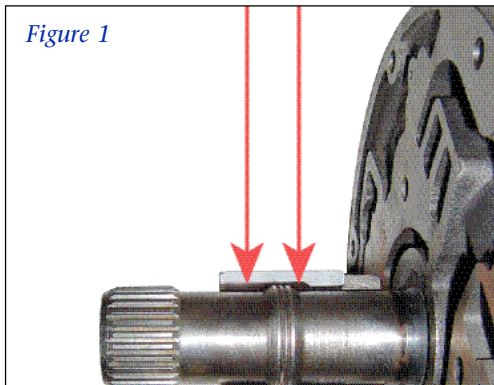
Figure 1

Since the impeller hub was the only part changed, the search for the root cause focused on that part. Many high performance converters are smaller in diameter and thinner through the cross section than the OEM converters they are replacing. A taller impeller hub is needed on these converters to maintain their correct over-

all height. The availability of longer-than-OEM impeller hubs for TF8 converters is limited, so a GM 400-style taller hub was substituted. Unfortunately, the I.D. of the GM hub was smaller than the I.D. of the TF8 hub and this caused the poor converter charge condition. The impeller hub was bored to the same I.D. as the OEM hub and the vehicle's consistent performance was restored.

The stator supports of the 400 and TF8 both have a raised area located behind the stator splines. The raised area on the 400 measures 1.425", and the raised area on the TF8 measures 1.485". The corresponding 400 and TF8 impeller hubs have I.D. profiles that maintain a clearance of .085" per side between the I.D. of the hub and the raised area on the stator support. When the hub with the smaller I.D. (400) was mated to the stator support with the larger diameter raised area (TF8), the converter charge oil was restricted. It was easy to see why the minimal clearance between the hub and stator support would restrict oil flow (see Figure 1).

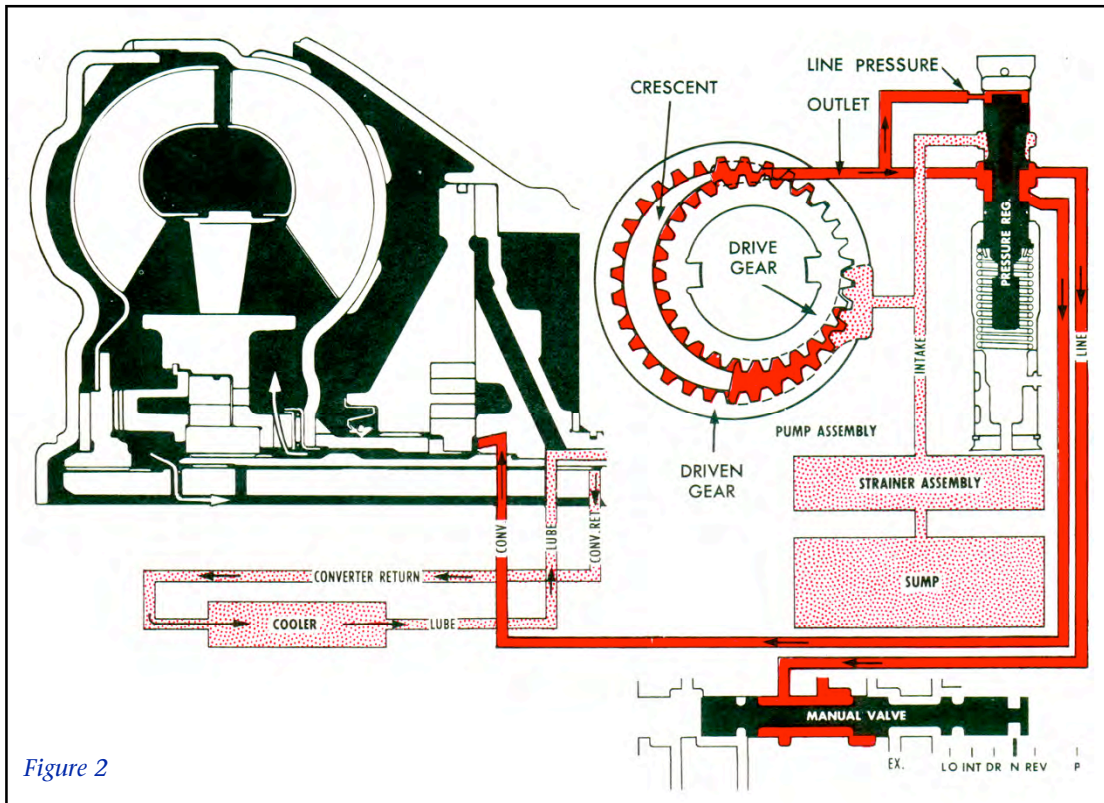
Figure 2

The only problem was that the charge oil did not increase as a result. In fact, it decreased.

Why would decreasing the area of flow and increasing the area of flow both result in less converter charge oil? To solve the mystery you must have an understanding of the relationship between the orifice created between the raised area of the stator support and the impeller hub, and the balance port of the pressure regulator valve. When the PR valve is at rest, it is in the high pressure position. When the engine starts, the pump begins to create pressure (line pressure). This pressure moves the PR valve against the opposing spring pressure and opens the port for converter fill (charge oil). Any time you raise baseline pressure, whether by installing a stronger spring or turning in on the EPC base adjustment, the PR valve will move to a higher pressure position and the converter charge port will be smaller. In the transmission field it is universally accepted that enhancing line pressure slows converter fill. If you consider the effect the PR spring has on converter charge oil, it is easy to see how the balance oil on the opposite end of the PR valve could also affect converter charge. Looking at the oil chart in Figure 2, you can see how the raised area of the stator directly affects the balance of the PR valve, keeping it in the maximum fill position. If you look at the close proximity of the components in Figure 3, it is even easier to understand.

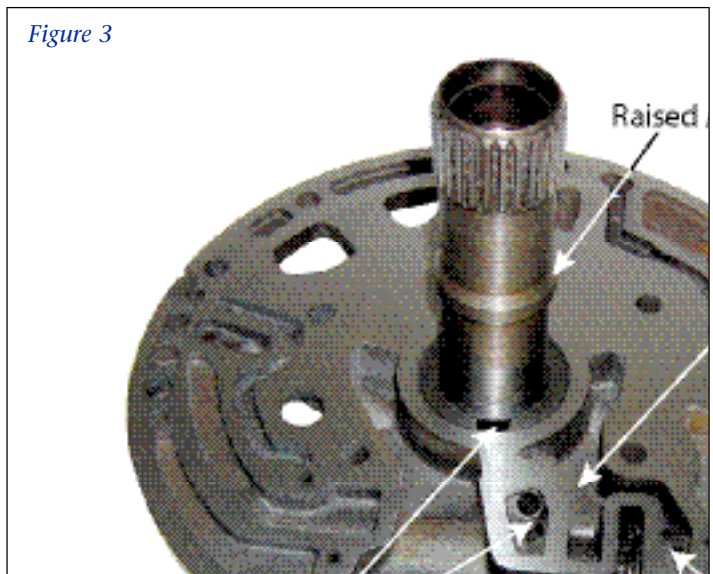
Figure 3

verter, the charge/release oil must enter between the piston and cover. On some lockup converters TCC apply oil passes between the hub and stator. On these converters the hub to stator restriction/orifice controls how fast the apply oil enters the converter. In either case the impeller hub I.D. should not just be looked at as a clearance issue. It is much more important.
