THE TORQUE CONVERTER JOURNAL

Volume 4 Number 2

BLAME THE TORQUE CONVERTER

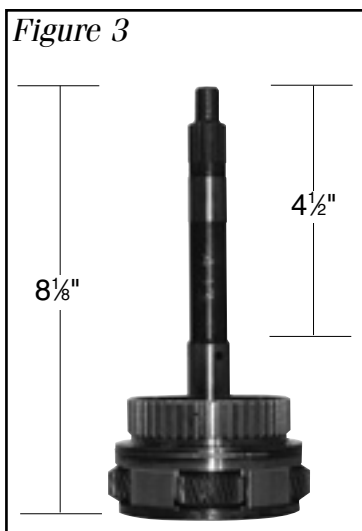
shaft was an integral part of the OD planet. He decided to check the OD planet to see if there was some type of flow difference with the replacement input shaft. What he found was that the replacement OD planetary was $\frac{1}{8}$ " shorter than the original. The tip of the input shaft was just making contact with the seal in the turbine hub. No wonder full clamping force could not be attained. Multiple ratios are not the only differences in the OD planets used in the 340 transmissions. Some ratios are also available in more than one length. The 4 cylinder OD planet measures $8\frac{1}{8}$ " long (**Figure 3**) and the V6 and V8 OD

In this situation, putting the 4 cylinder planetary into the V8 transmission had caused the problem. Once again, the converter was not to blame.

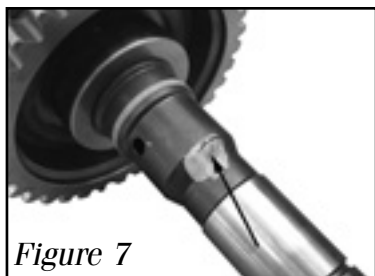
demand was low. In this situation there was sufficient oil flow most of the time and the vehicle would only set a code every week or two.

The figures illustrate the flow area difference created by the two different supports. **Figure 6** shows a small amount of plumbers putty placed on the 4T65-E turbine shaft before it was inserted into a 4T60-E drive sprocket support. The putty is being used like Plastigauge® to visually demonstrate the different clearances. **Figure 7** shows the putty compressed or removed by the support. Notice how much more putty remains after the same shaft with new putty was inserted into the 4T65-E support (**Figure 8**).
