Sonnax Technical Bulletin

ACCUMULATING COST-EFFECTIVE FIXES

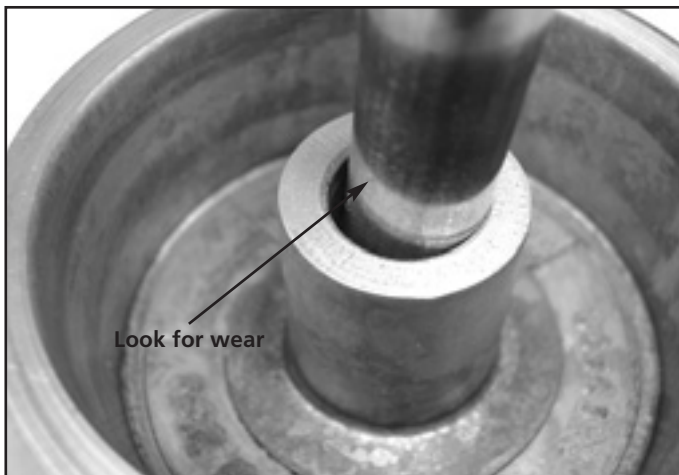
The design intent is for the shift to be completed during the stroking of the accumulator piston. That means that the piston is stroking under considerable pressure every time the device is applied, often wearing out both itself and the case bore in which it lives in the process. That wear leads to a litany of complaints. If pressure builds to apply too fast, you get end bumps or bangs. If pressure builds too slowly, you end up with long slide shifts or flares. There has to be perfect timing between the action of the piston and the clutch.

Worn Accumulator Piston Pin Bore

For GM 4L80-E applications, Sonnax offers a 4th accumulator bore and pinless accumulator piston to salvage a galled accumulator body. Kit number **34805-01K** includes a press-in replacement sleeve and a pinless accumulator piston with a Teflon® guide ring to support the piston in the bore.

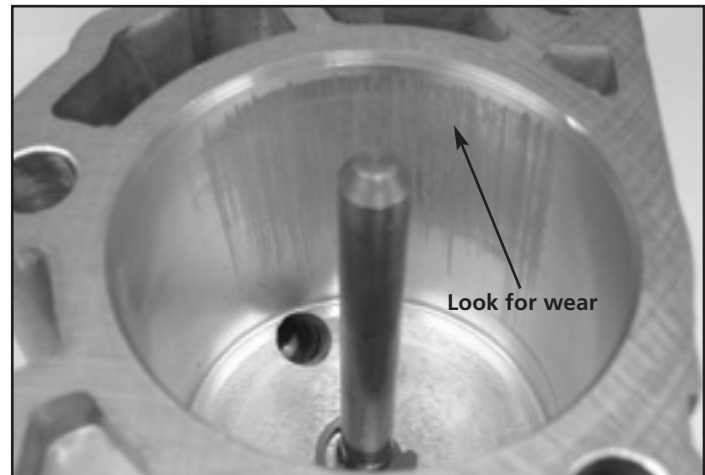
Worn Accumulator Bore

For Chrysler units (A727, 42/46/47RH/RE and 904), there's **22841-01K**, an intermediate accumulator repair kit that will salvage damaged cases. The kit comes with an undersized accumulator piston as

well as two sleeves and seals to repair both the small- and large-diameter pistons. This is a drop-in solution that requires no machining.
