Author: **Ed Lee**

## Mercedes 722.6: Cold Stall/TCC Shudder Part I

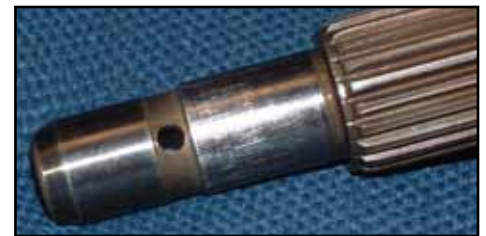
*Figure 1*

lockup or to allow apply circuit oil pressure to exhaust when the TCC is released. The apply oil travels through the input shaft and exits between the smaller and larger diameters of the smooth areas at the end of the shaft (**Figure 1**).

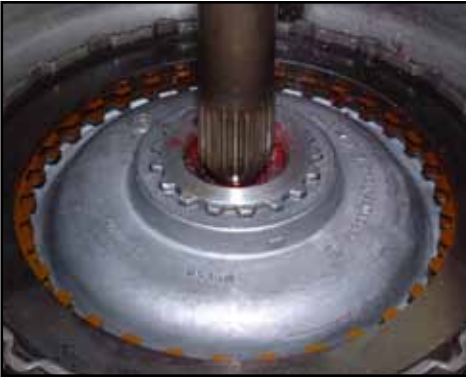
The oil that exits the shaft travels into the aluminum tower that is part of the cover. The I.D. seal of the TCC piston seals on the O.D. of this tower. The smaller and larger diameters of the input shaft use different methods of sealing between the shaft and the mating surfaces of the cover tower. The smaller diameter uses an O-ring or lathe cut seal, while the larger diameter relies on an interference fit. The cover tower rotates at engine RPM. The input shaft RPM can range from zero at a standstill to the same as engine RPM during full lockup. The potential RPM difference between these mating parts makes you wonder why either the O-ring/lathe cut seal or the interference fit options were chosen for this application in the first place. A radial lip seal would seem to have been a much better choice. Despite the possible poor choice of seals, many technicians have reported successfully fixing both cold stall and TCC shudder problems by restoring the integrity of these seals. The leak visible in **Figure 2** was a result of bore wear at the interference fit of the tower.

One mating surface is the larger diameter of the input shaft and it measured .660". The other mating surface, the cover tower bore diameter, measured .683". The bore diameter

of a good OEM tower measures .662". The difference between the .002" factory intended clearance and the .021" clearance of the worn bore pictured here resulted in a

7.5 gallon per minute (GPM) leak, not to mention both cold stall and TCC shudder issues. This issue was resolved by removing the O-ring/lathe cut seal, blocking the lube bypass passage, and installing a radial lip seal (**Figure 3**).

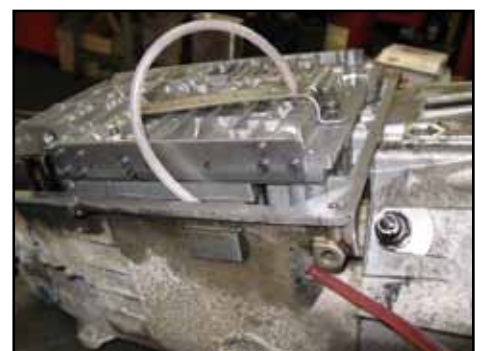
**Figure 4**

mission case. With the valve in the release position, this circuit is directly connected to the TCC apply oil circuit (**Figure 4**).

As fate would have it, the clear plastic hose that exited the transmission was run vertically upwards. This made the hose act like a stand pipe and, when the engine was started, the fluid rose about one foot up the tube and stayed at that position. This information proved to be critical.

The oil rise in the exhaust circuit tube showed that there was a pressure rise in the TCC apply circuit when the engine was started. More specifically, it showed that

there was residual oil trapped behind the piston and, when the engine was started, centrifugal force was causing the piston to apply (as well as pushing oil further up the tube.) If there was no residual oil trapped behind the piston, the problem would not exist. Lacking any viable check ball or hydraulic option to purge the residual oil, a mechanical option tried. The middle
