Article No.: TCTIP-10-08

Blame the Torque Converter II

2001 Chevrolet Impala 1811 and 741 Codes

2001 Volvo 740 Code

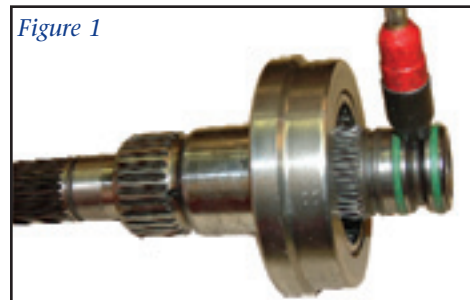
Figure 1

Mike Souza from ATSG wrote a great article (Transmission Digest April 2008) explaining this problem. The technician used the article as a reference to prove that this was causing the P0741 code, but when he applied air pressure to the TCC apply port on the 4T65-E turbine shaft (Figure 1), he got a full stream of air out of the TCC apply port on the

4T60-E drive sprocket support. At that point he was no longer sure that he had found the problem.

There is enough clearance between the 4T60-E drive sprocket support and the 4T65-E turbine shaft to allow enough flow to pass an air check. The customer did not drive in any hilly areas and did not carry any passengers, so the lockup apply pressure demand was low. In this situation there was sufficient oil flow most of the time and the vehicle would only set a code every week or two.

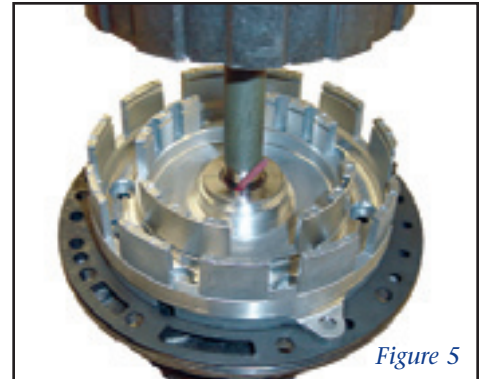
Figure 5

fact that replacing the pump was the only change made to the unit. The replacement pump was found to be the reason for the 740 code. There are two different diameter input shafts, .844" and .870", and two different pumps with stator bushings to

mate to the shafts. **Figure 5** shows a piece of gasket material fitted into the overly large clearance that results when a small shaft is used in the large pump bushing.

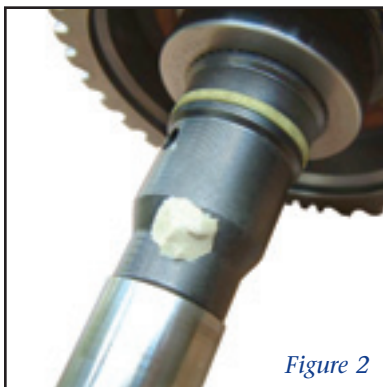
Figure 2

The figures below illustrate the flow area difference created by the two different supports. **Figure 2** shows a small amount of plumbers putty placed on the 4T65-E turbine shaft before it was inserted into a 4T60-E drive sprocket support. The putty is being used like

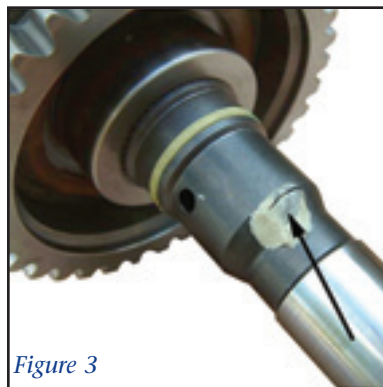
Figure 3

Plastigauge® to visually demonstrate the different clearances. **Figure 3** shows the putty compressed or removed by the support. Notice how much more putty remains after the same shaft with new putty was inserted into the 4T65-E support (**Figure 4**).
