Author: **Ed Lee**

Mercedes 722.6: Cold Stall/Shudder Part II

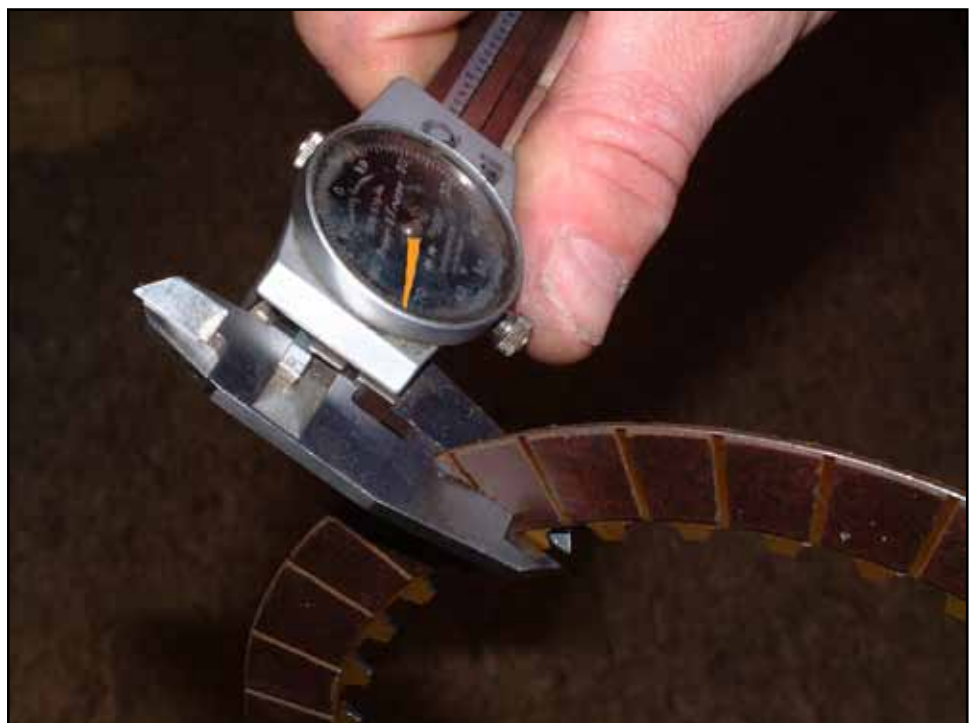
Figure 1

When the converter was inspected, excessive wear was found on the TCC frictions. The clutches did not visibly show the wear, but on the frictions it measured as much as .040" per clutch. (**Figure 1**)

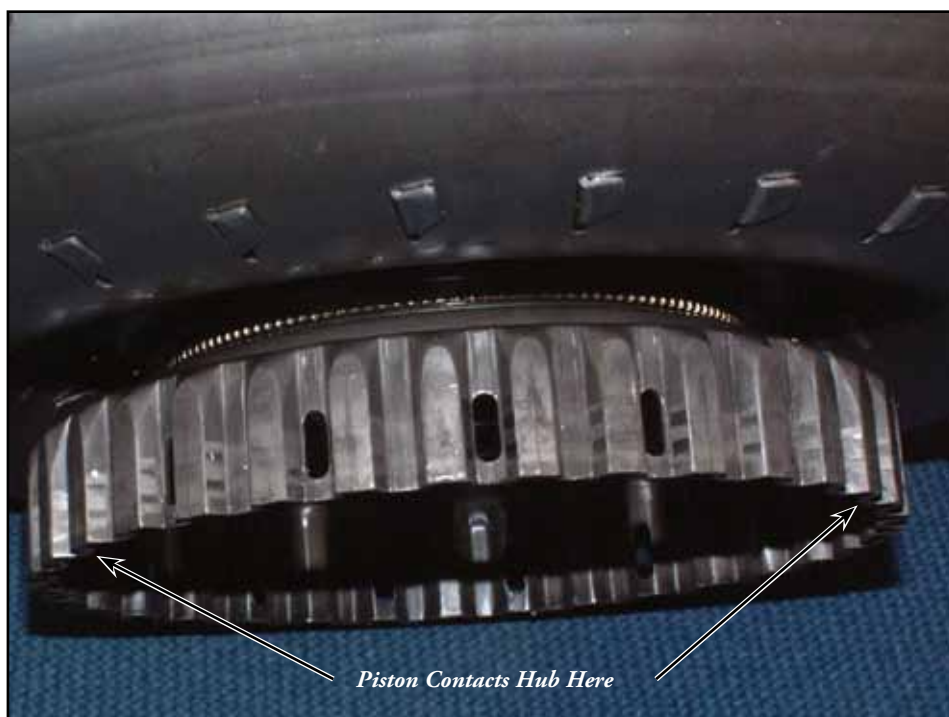
Figure 2

This created extra clearance that allowed the TCC piston to come into contact with the clutch hub, reducing TCC clamping force. (**Figure 2**)

The vibrations caused by the TCC dragging at low speeds also contributed to excessive clutch wear. This wear was allowing TCC slip, felt in this case as flares on the upshifts. The material that was worn from the TCC frictions was responsible for restricting the transmission filters.
