Converter Conundrums

The top 3 converter vs. transmission issues of 2010

TCRA 2010

Presented by:
Bob Warnke

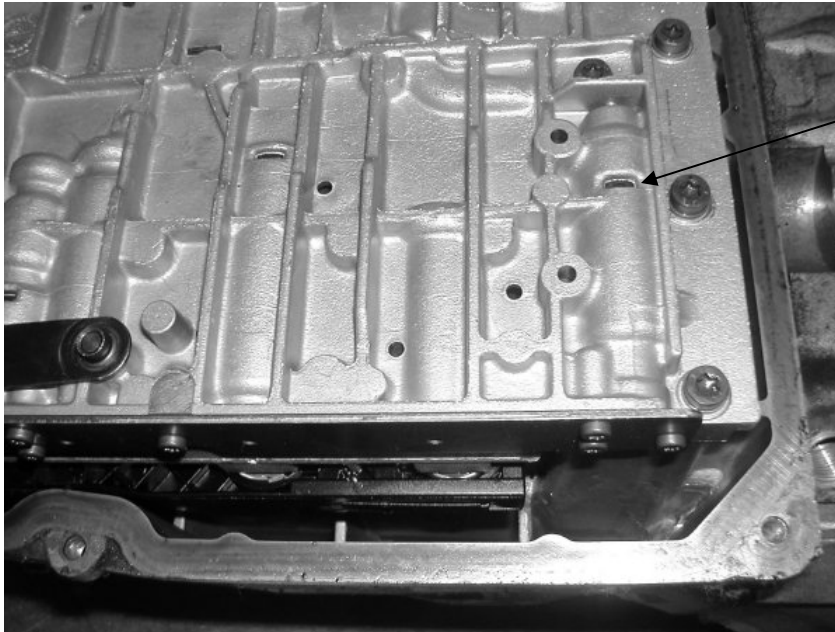
TCC Exhaust

Air pressure will charge the TCC Piston from opposite side.

The TCC apply circuit can be air tested, (30-60 psi.) with the unit in the vehicle and the valve body in place. Charge the exhaust hole. The air supplied will push remaining fluid into the converter TCC piston. Minimal leakage should come out cooler lines or other valve body locations.

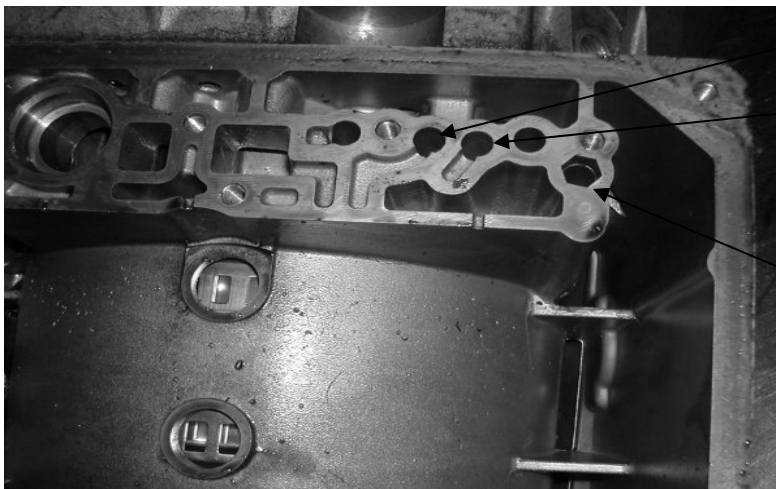
If the valve body is removed, the three converter circuits can be isolated. Any leakage from converter charge or converter out, is from cross leak at the pump or within the converter.

Note: Teflon type of sealing rings require fluid to lift. If air testing with a dry circuit, they will cross leak. Turbine shaft sealing rings should be the OE overlap design. Valve body must be flat and the pump stator or converter cross leaks should be eliminated. Internal transmission bushings insure the turbine shaft runs true, a requirement for the rings to seal.

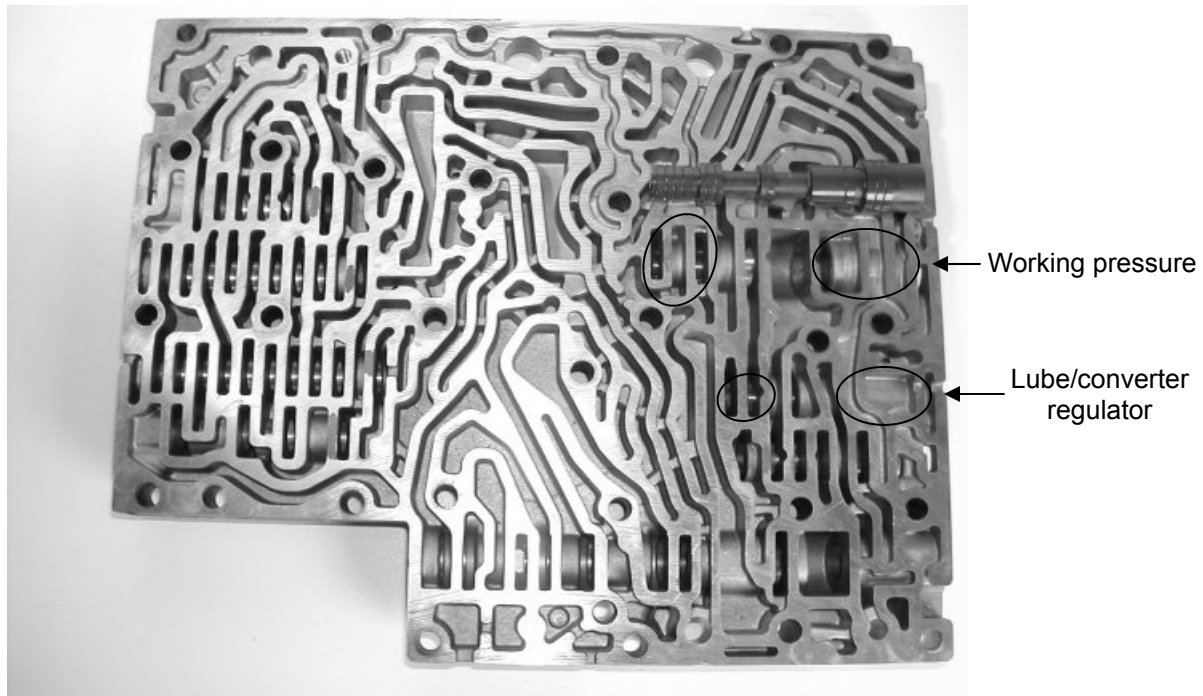
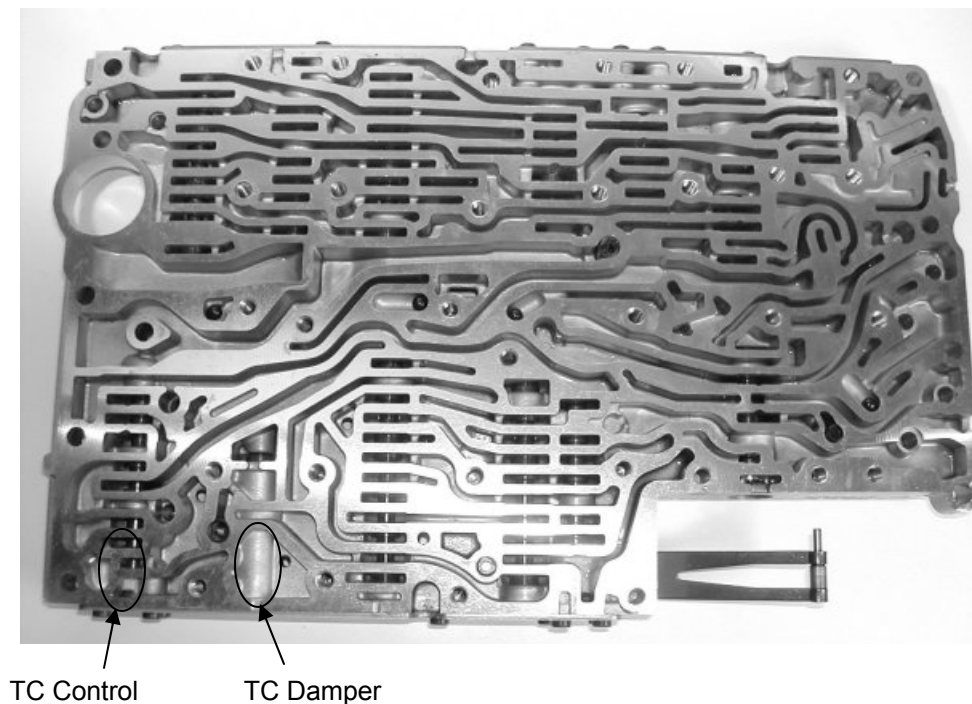
2: Low converter apply pressure extends from the main/working pressure regulator bore and the Lube/converter limit valve. Wear at either area affects TCC and converter charge psi. Critical wear points within circles (shown in photos below.) The TC control valve must stroke for full apply. Bore wear at either location reduces the TCC solenoid's ability to stroke the valves.

2: Visual or vacuum test the working pressure regulator, the lube/converter limit, the torque converter control and the TCC damper piston.

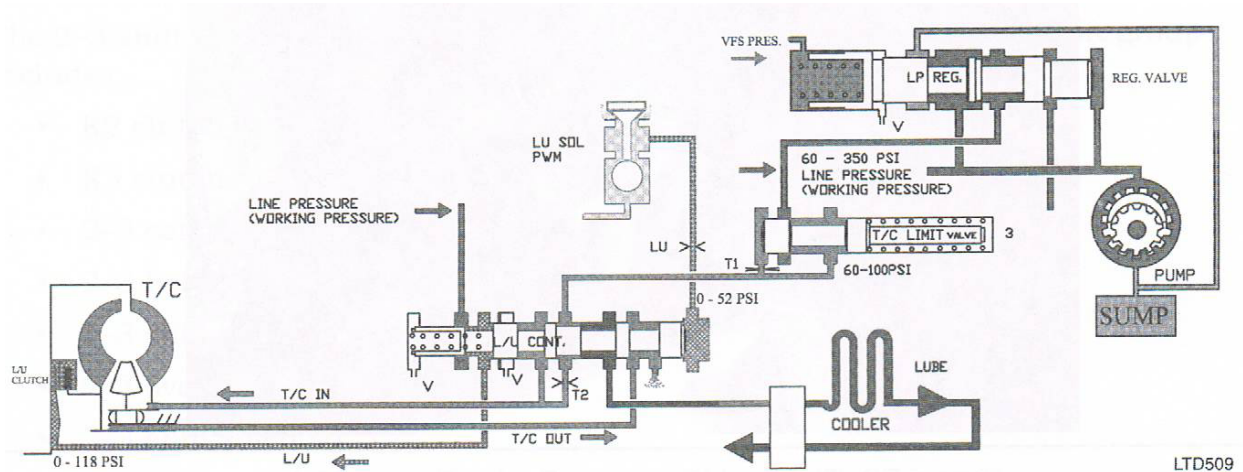
3: The normally closed, Y3/ 6y6, TCC solenoid strokes the torque converter lockup valve. If the Y3 solenoid leaks into the control valve circuit, the valve may rest in a partial apply position.

3: Test, replace Y3 lockup solenoid.

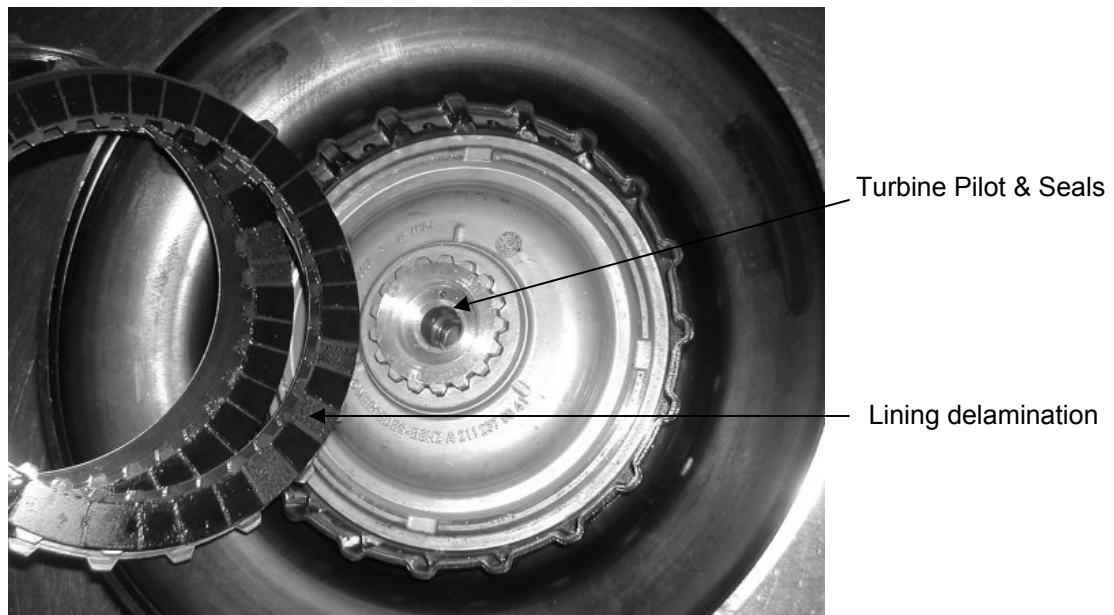
Mercedes kit # 000-989-009 and 000-989-0014

4: Test for water or antifreeze in ATF. In some applications, one drop is sufficient to degrade clutch linings.

An alternative is to use a hot plate and check for a sizzle noise as the water burns off.

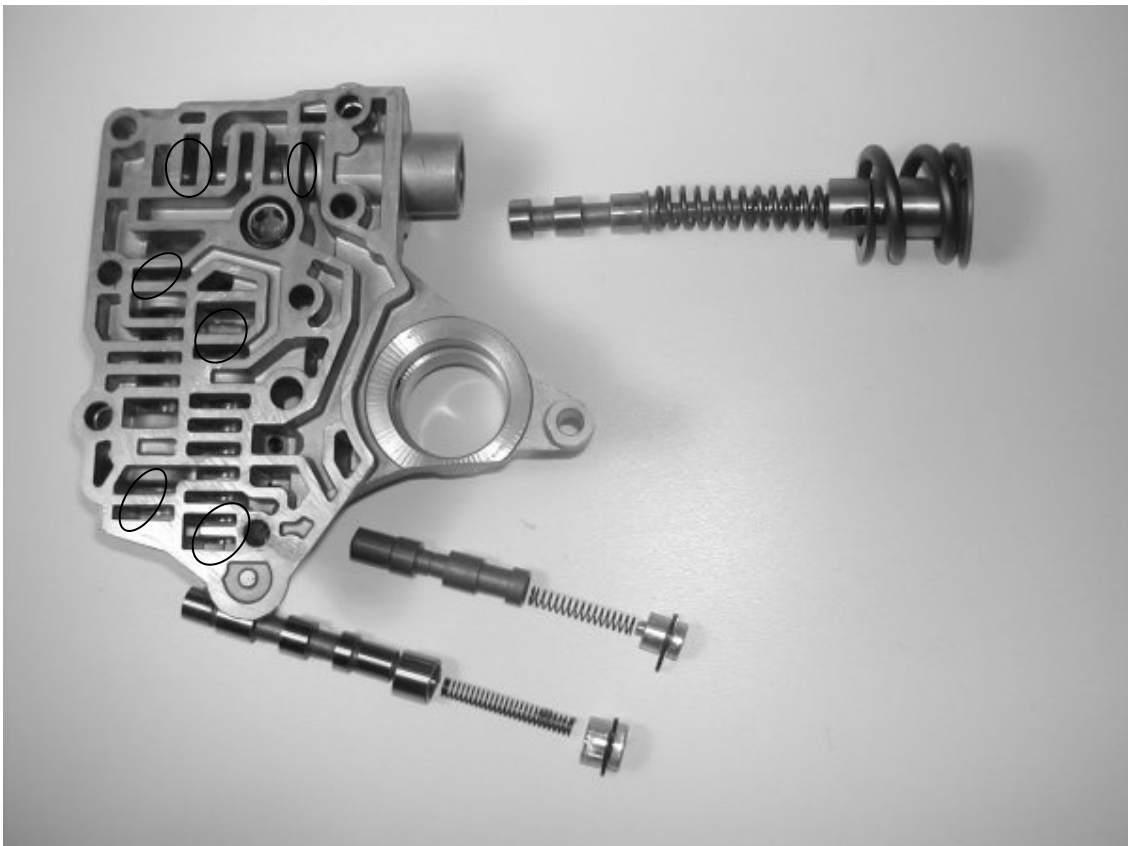
1: Main control body bore wear (critical points at circles.)

Control valve body worn at the converter relief bore.

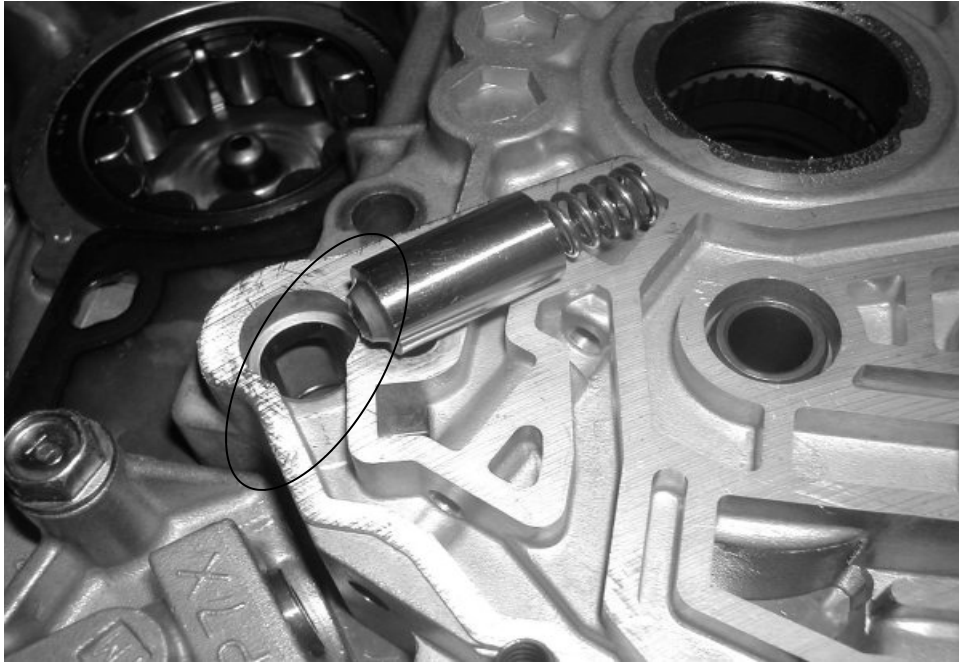
To isolate prior to removal, compare scanner data to the cooler flow. You should see the TCC command and amperage change in parallel to a cooler flow change on a SonnaFlow.

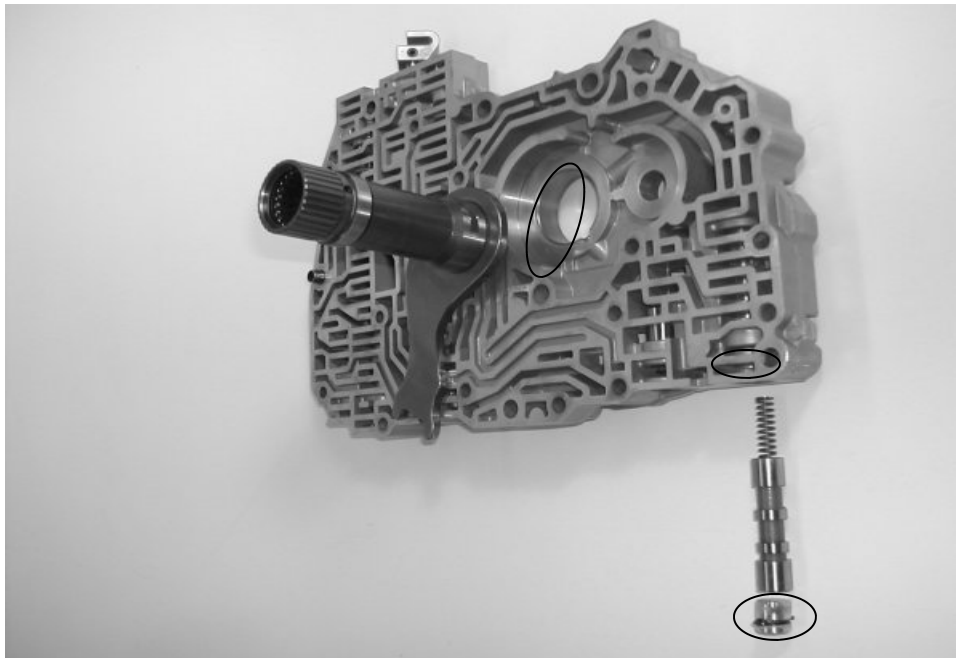
Loss of TCC or TCC slip: Created by end plug loose at the TCC control valve. A cross leak of converter charge oil into TCC control negatively affects TCC control. Inspect the stator for cross leakage at the finished area, where it passes through the casting.

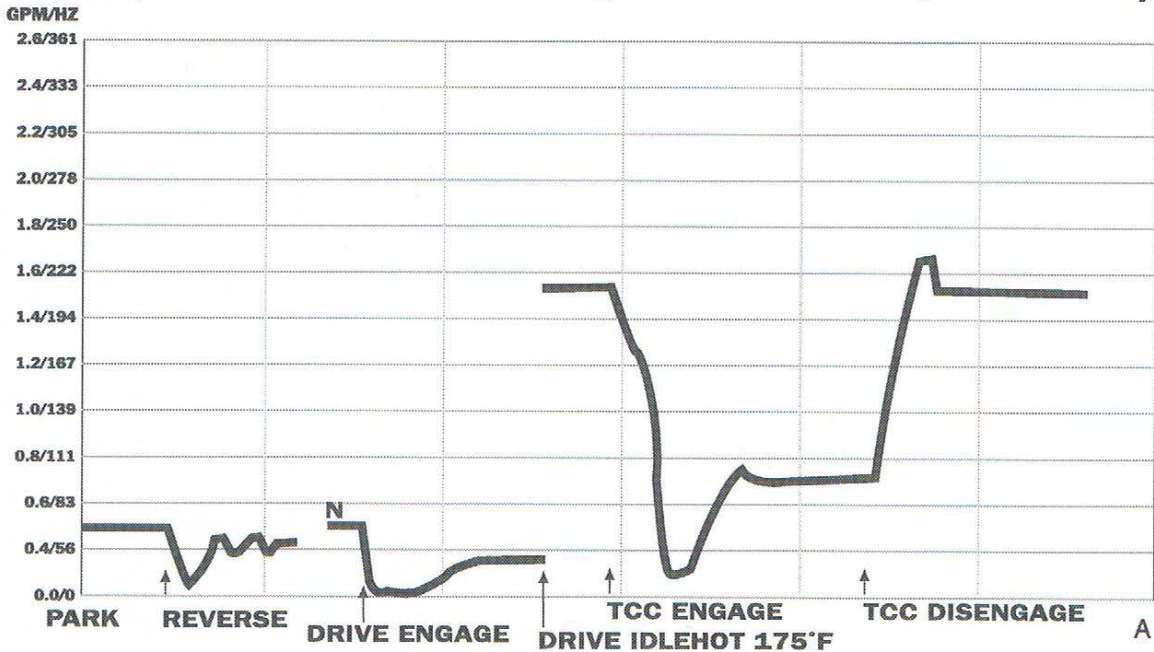
BAXA ('98 Honda Accord 4 cyl. USA built 83,750 miles)

Notes: Drive idle flow would drop to .3-.2-.1 at times, while brake torque would go up to 2.0. Park to reverse would be a smaller dip than neutral to reverse. Reverse to drive could see first dip for list clutch and second dip for no release.

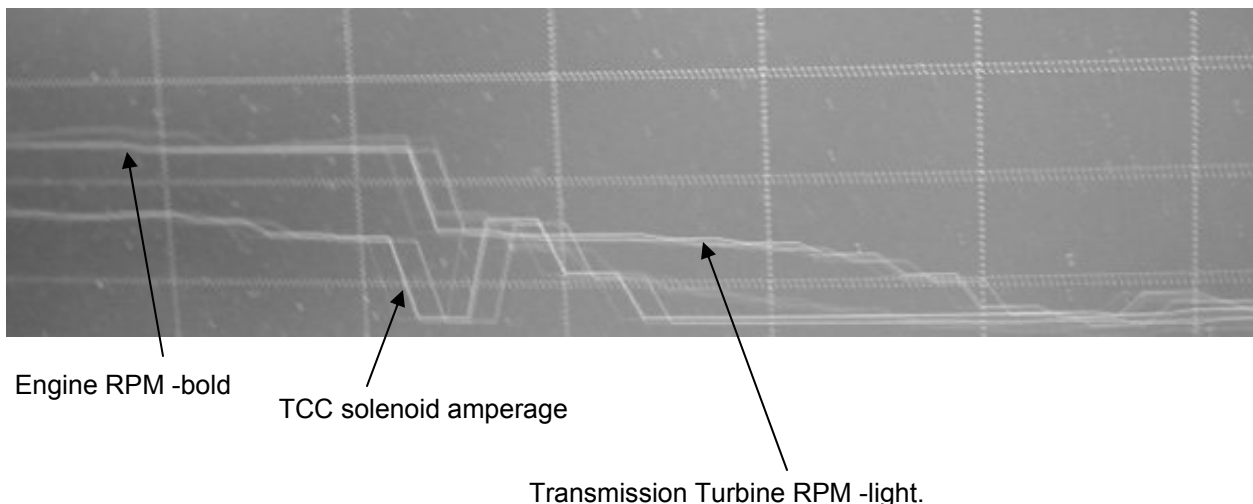
With a scanner; monitor the TCC solenoid. You should see amperage change as it's modulated briefly to open the converter.

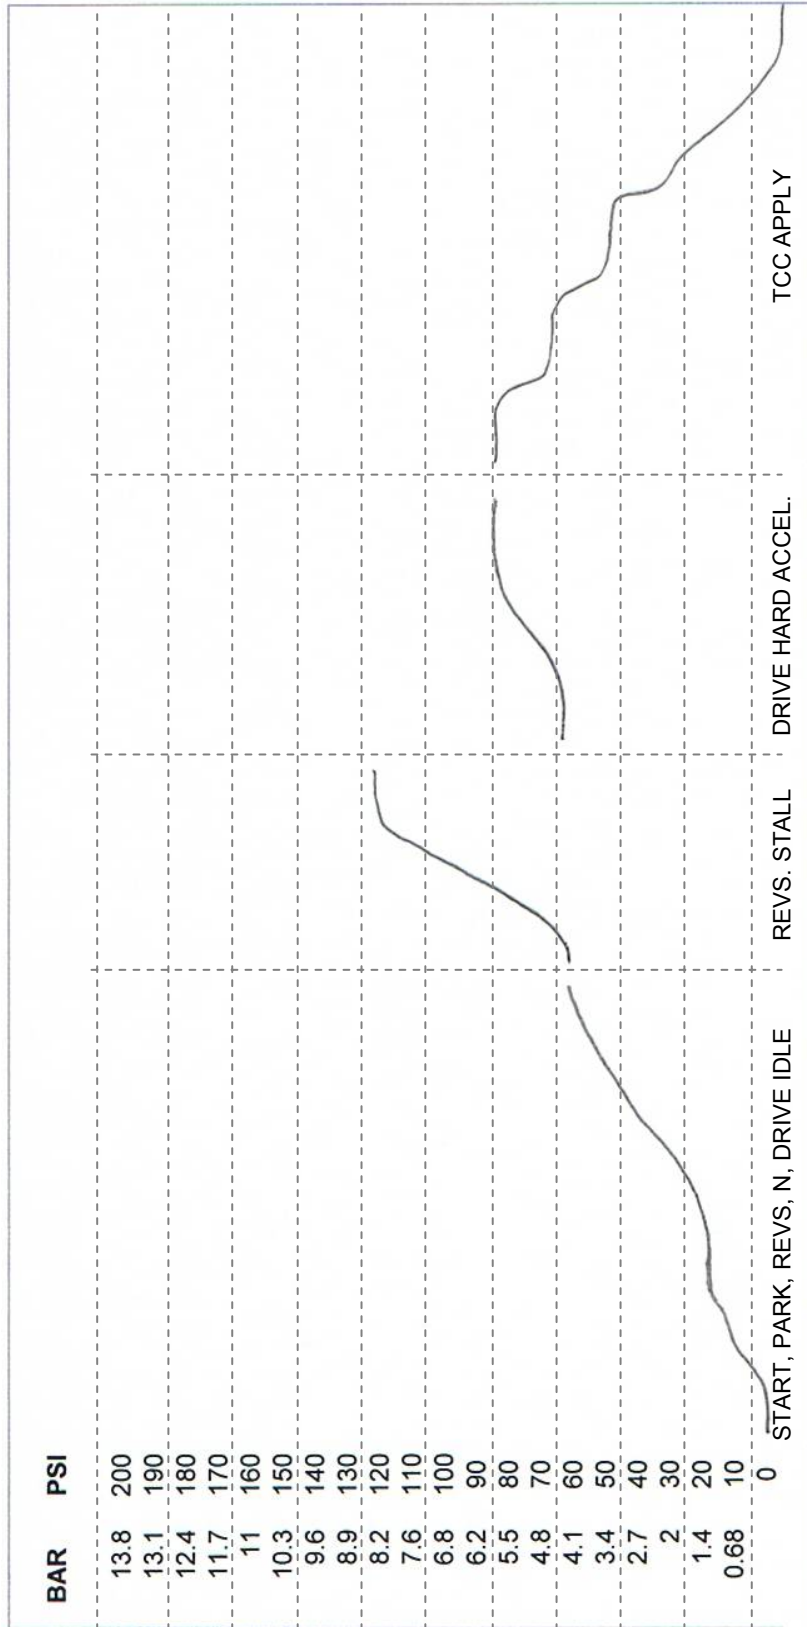
AW6 CONVERTER RELEASE PRESSURE (Typical)

Note: Tapping release pressure is a good method to verify operation of #4-N 91 solenoid.
TCC modulates off-on during 4-5-6 gear shifts. This tap is a method to verify TCC is affecting shift quality.
TCC modulates on after 1-2 shift.
TCC cut off during Tip-Tronic up & down shifts
TCC remains on during coast down.
If cooler release pressure is low, check fluid level!

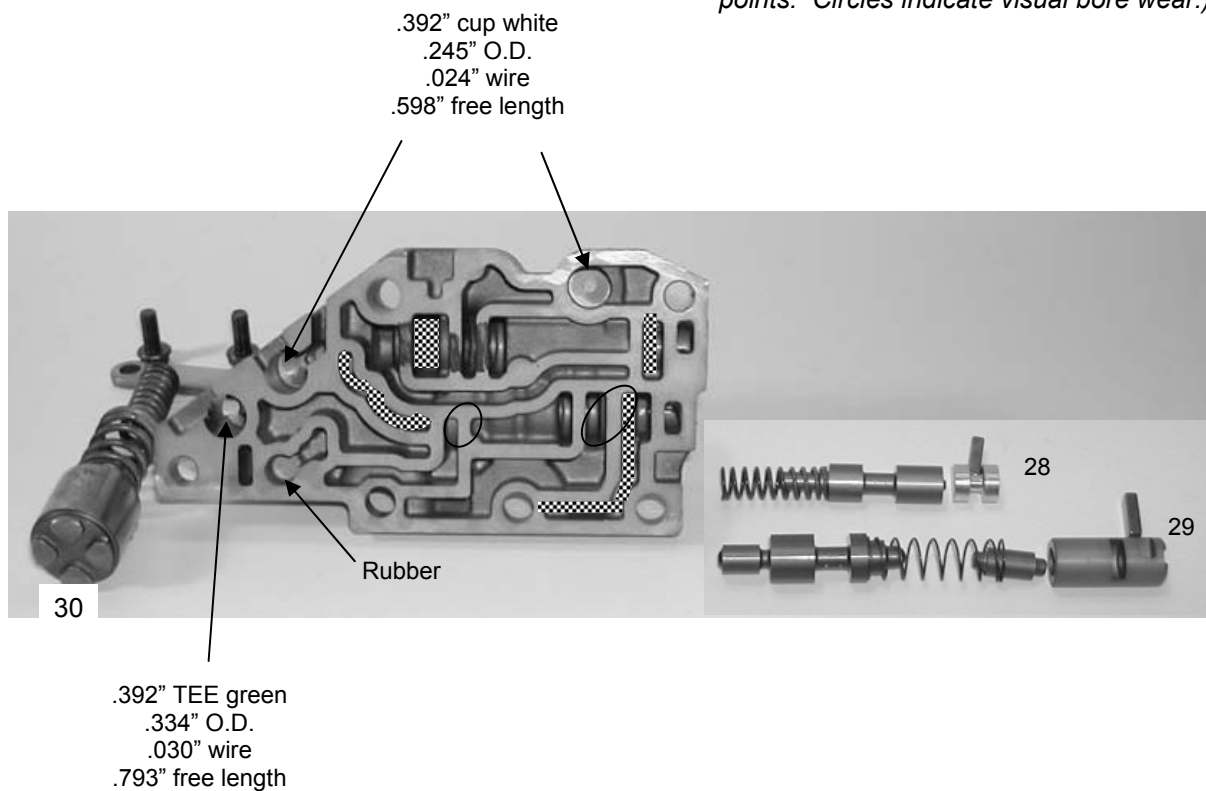
TF-60SN / 09G

(The dotted areas indicate vacuum test points. Circles indicate visual bore wear.)

1: Visual inspection, WAT or vacuum test the TCC control bore at the inboard end and the outboard sleeve. If worn ream or replace the valve body. Aftermarket valve body rebuilders generally have these in stock.

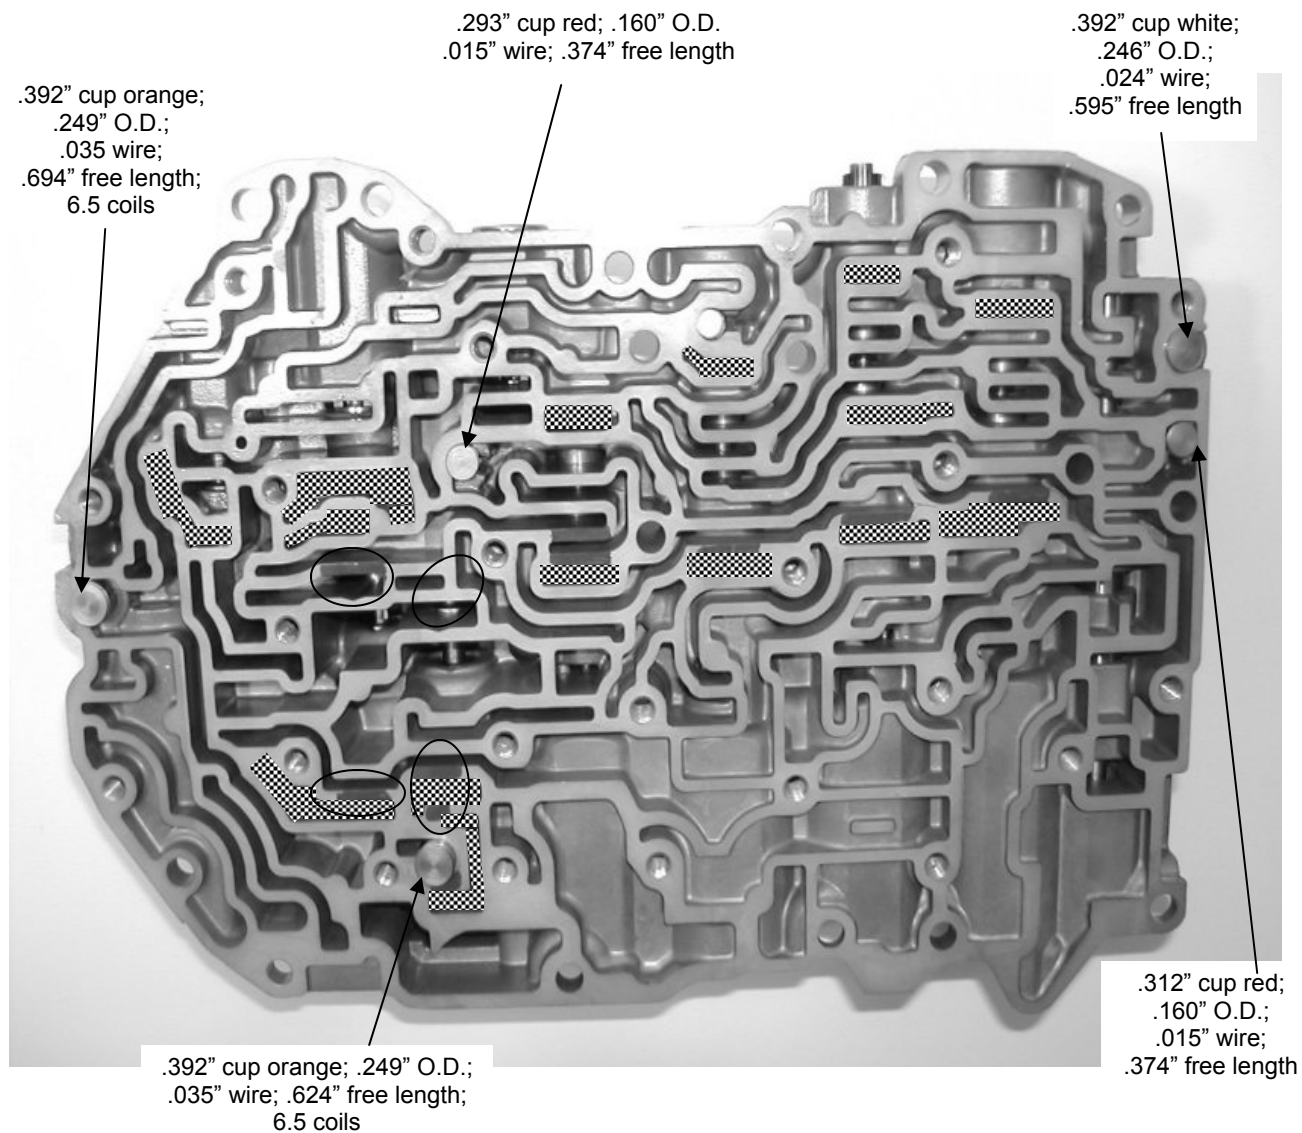
TF-60SN / 09G

Relief is not in all TF60 units.
No hole in plate=no relief.
