A Fix for 5R55W Front Planet Bearing Failure

By Ed Lee

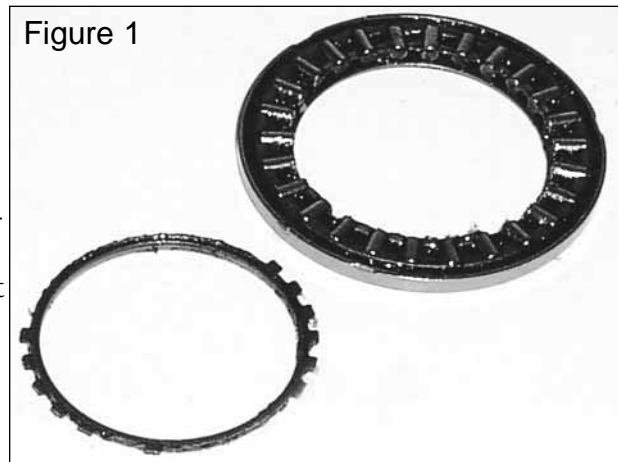
The problem with the 5R55W was that the center of the bearing cage on the sun gear side of the bearing would get stamped out, and this would eventually lead to catastrophic failure. In this event, replacement is the only option, and the replacement part is available from Ford (p/n 2L2Z-7A398-AA) for a couple hundred dollars. The original bearing is not available separately from the dealer and even if it were, it could not be replaced without disassembling the planet.

Figure 1
The center of the bearing cage on the sun gear side of the bearing in a 5R55W can get stamped out, leading to catastrophic failure.

If you're lucky enough to catch the problem with the planet before catastrophic failure has occurred, there may be an option other than replacing the planet.

The original bearing was centered by the planet side bearing race and the clearance fit cavity in the sun gear that mated to the opposite race. Provided that the planet side race is serviceable, you may substitute another bearing in the original planet. In this case, the bearing that rests between the stator support and the direct drum in the RE4F02A transmissions is a good choice.

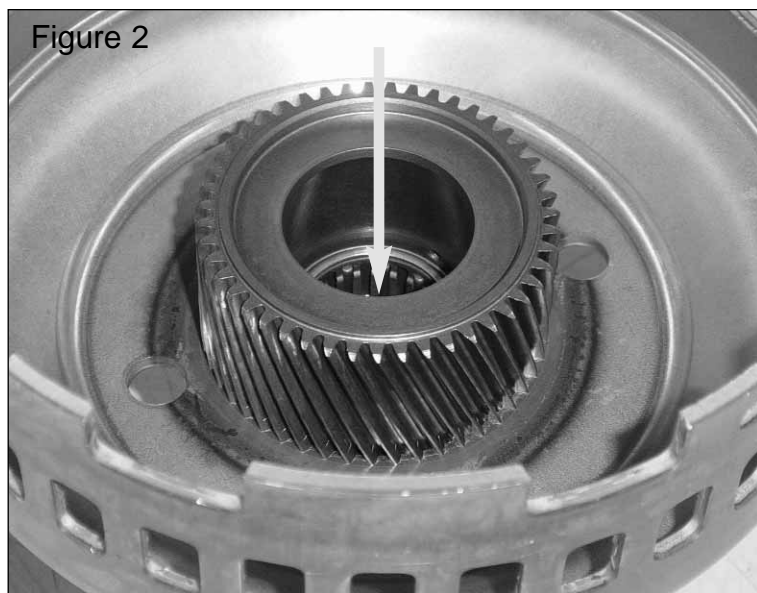
Figure 2
The arrow shows the recess in the gear where the RE402A bearing fits.

The O.D. of this bearing provides a good fit in the sun gear, and the I.D. has sufficient clearance. The replacement bearing is .020" thinner than the original bearing, but this is not a problem. The aftermarket replacement shim for adjusting the front endplay on 700 -R4 and 4L60-E transmissions is made to order for this job. The shims are available in thicknesses of .010" (Sonnax p/n 77406-10) and .015" (Sonnax p/n 77409-15). Place the appropriate shim between the sun gear and the bearing, and you're back in business.
