12-VALVE CUMMINS DIESEL/618 TRANSMISSION NO O.D. WHEN COLD, IN & OUT OF O.D. WHEN HOT

By Ed Lee

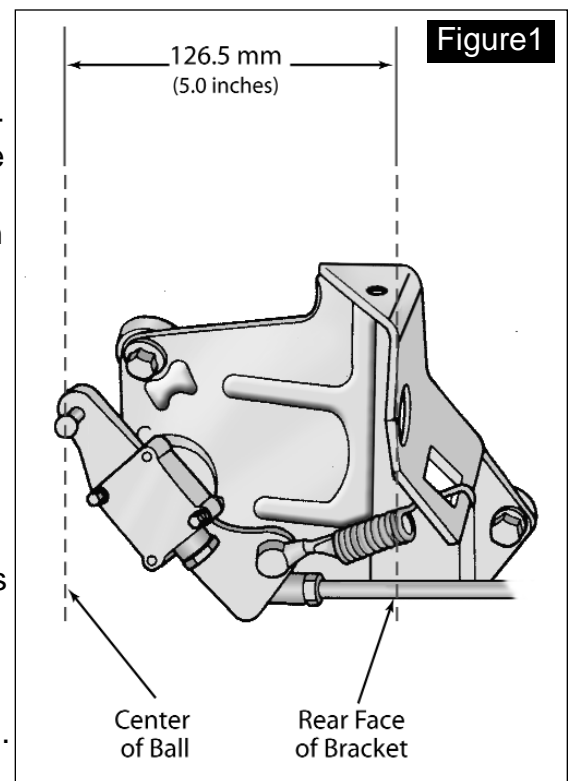
At this point you would think that the TPS was defective, and many good throttle position sensors have been replaced on the basis of this reasoning. The actual root cause of the problem was a throttle linkage rod that was out of adjustment. The throttle linkage rods have always had a problem with corrosion at the joints of all 5.9L Cummins Turbo diesel engines. In July 2002 Daimler Chrysler, Inc. issued safety recall #B15 for diesel engine throttle linkage. Unfortunately for the consumer, the recall was assembly plant, date and V.I.N. specific. The earliest covered vehicle was manufactured at the St. Louis north assembly plant on July 22, 1996 (V.I.N. MDH0805XX). The recall ended at all three assembly plants on Dec. 31, 1997 (with V.I.N. 1231XX).

major concern. When the rod is adjusted properly, the distance between the center of the ball on the throttle lever and the back of the throttle cable mounting bracket will be 5 inches or 126.5mm (see Figure 1). The \pm variance on the adjustment is 1.0mm (that's the thickness of a dime) This bold-face warning is part of the instructions: Do not lengthen or shorten the linkage rod more than 1.0mm from the dimension 126.5 mm (5.0 inches). If voltage requirements can not be met by linkage adjustments (125.6 to 127.6 mm), replace the TPS.

When the throttle linkage rod is adjusted properly, as the accelerator pedal is depressed half way to the floor the throttle lever and throttle lever to injection pump lever linkage rod should both move. As the accelerator pedal is depressed past this point, the movement of the throttle lever-to-injection pump lever linkage rod should stop moving and the throttle lever will continue to move toward the rear of the vehicle. This visual check does require two people to perform, but may be worth the time spent in the long run.
