COMPLAINT

AW Boost Valve & Sleeve Kits

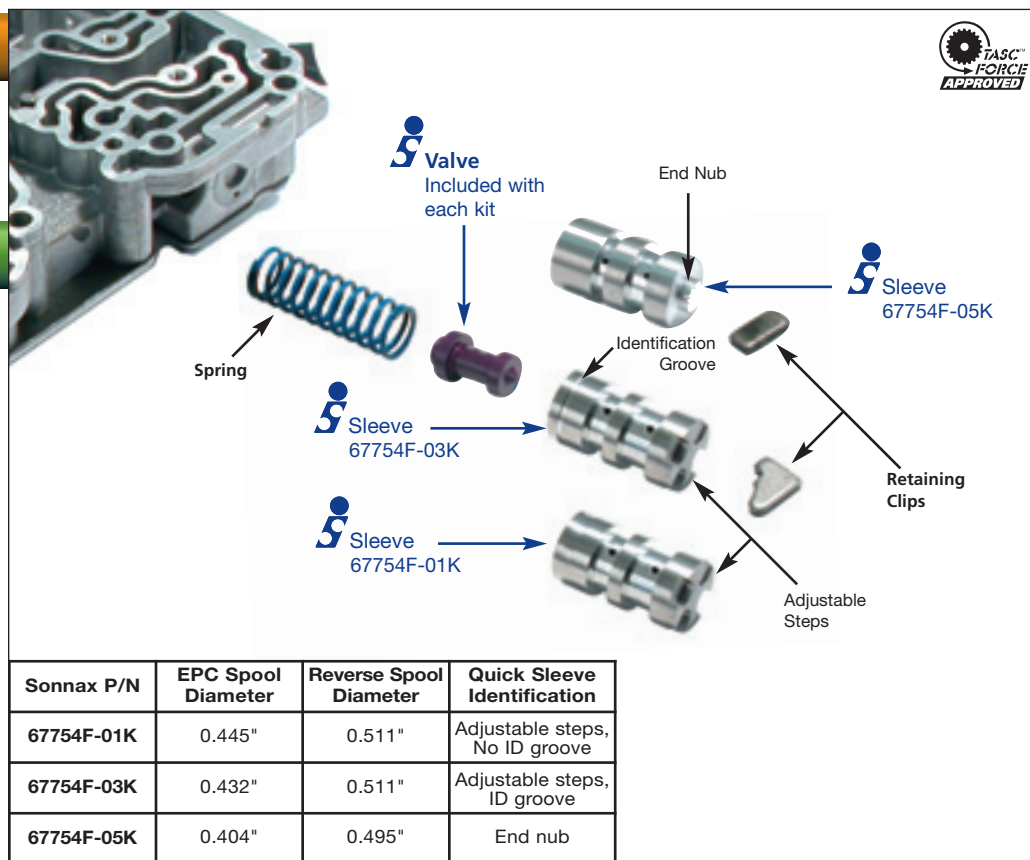
Continuous boost valve oscillation causes bore wear at the boost sleeve and allows EPC and/or reverse pressures to exhaust or cross leak.

Continuous oscillation of the OEM steel boost valve within the cast-aluminum sleeve causes bore wear at the boost sleeve and allows EPC and/or reverse pressures to exhaust or cross leak. Also, due to the differences in thermal expansion rates of steel and aluminum, as the vehicle reaches operating temperature, the clearance between the sleeve and valve may actually double and create a greater path for leakage. Sonnax now offers three replacement boost valve assemblies with upgraded materials to prevent future wear and reduce leakage due to thermal expansion.

These three replacement boost valve assemblies with upgraded materials will prevent future wear and reduce leakage due to thermal expansion.
