Article No.: TCTIP-02-2009

Mystery P0741 Code

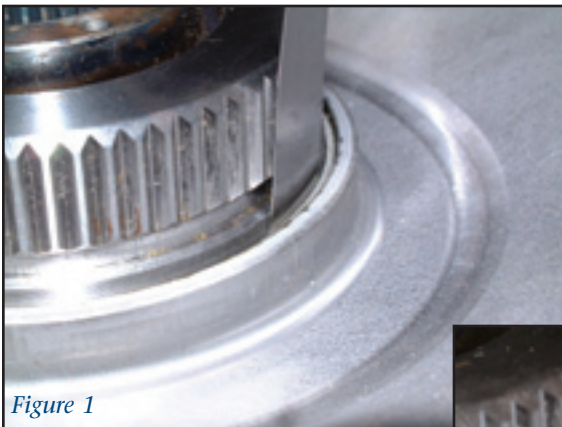
Figure 1

inspection. The bushing in the I.D. bore of the TCC piston looked like new, but there seemed to be more than normal clearance between the bushing and turbine hub. The O.E. clearance for this area, when the converter is new, is about .0015" to .002". As a general rule of inspection, for a unit that has been in the field: if a .002" feeler gauge fits between the bushing in the TCC piston and the turbine hub, the bushing is good. If a .003" feeler gauge is a tight fit, the bushing is marginal, but will work. If a .004" or larger feeler gauge will fit, the bushing must be replaced. Ken found that he could fit a .007" feeler gauge between the bushing and turbine hub on the problem converter (Figure 1).

Since there is no additional "O" ring or lathe cut seal located between the piston and turbine hub, the clearance between the bushing and turbine hub acts as an orifice. Almost 5 times as much oil was leaking past this area than there should have been, because of the excess clearance. Ken went back and checked the piston he had replaced the first time around. He found that an .011" feeler gauge would fit between the piston bushing and turbine hub. This extra clearance with either piston would explain

the P0741 code, but why was the clearance there?

Most converters rely on an o-ring or lathe cut seal to control oil flow between the turbine hub and TCC piston. Because the 4R100 or 5R110 converters do not have any seal in this area, it becomes critical that this clearance be measured during the rebuild process.

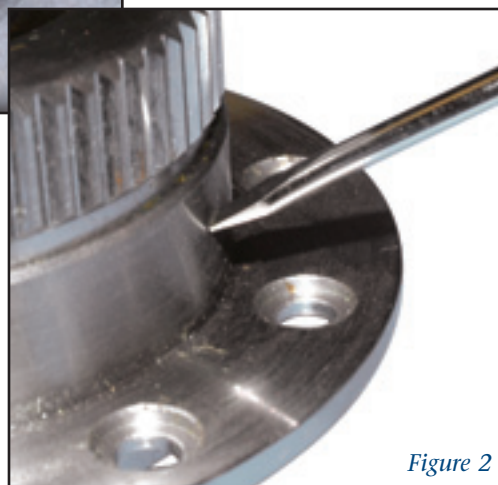
Figure 2

When the Oregon Converter Company rebuilt the converter, they reused the turbine hub, which looked like new. The turbine hub had been replaced by the original rebuilder. Unfortunately, the surface finish on the turbine hub, where the bushing in the I.D. of the TCC piston rides, was rough enough to wear the bushing out prematurely. The surface finish for this area should be in the 10 to 20 R.A. range. The surface finish on this turbine

hub exceeded the profilometer's maximum reading of 200 R.A., and a good guess would put this turbine hub's finish at about 300 R.A. The finish was rough enough to catch a fingernail but was difficult to detect visually. In fact, the O.D. of the problem turbine

for smoothness is to run your finger nail across the surface, or place your pocket screwdriver at a 45 degree angle to the surface and push it across the surface (Figure 2).

hub measured the same as an O.E. hub, and felt smooth when you ran your finger around the circumference. If you do not have a profilometer, the best method of checking
