Author: **Ed Lee**

## Cast Iron Powerglide® Leaks

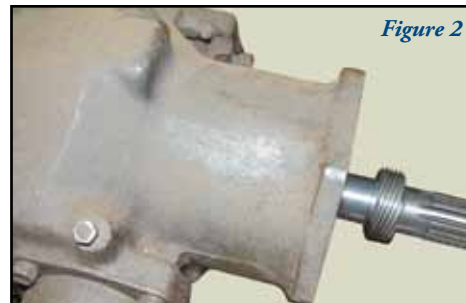
*Figure 2*

grouped together, the majority of the reported leaks were in the 1949-1957 units. The 1958 and newer units had relatively few reported leaks. A closer look at the different years explained the difference. For the 1958 model year, Chevrolet added a vent to the rear of the main transmission case (*Figure 1*). Previous years did not have a vent (*Figure 2*).

To retrofit a vent to the earlier transmissions, a 90° brass fitting was added to the extension housing. A length of fuel line hose with a plastic vent from a 350 transmission was attached to the fitting. The end of the hose

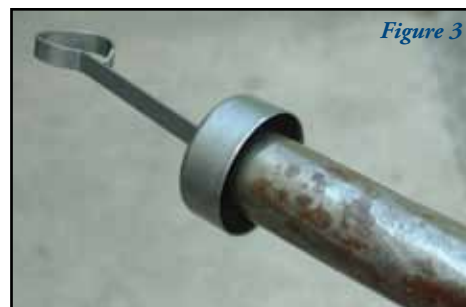
*Figure 3*

Before 1958, the only vent for the transmission was the opening at the top of the fill tube. The dipstick did not have a positive seal, and was designed to allow air to enter and exit the transmission (*Figures 3 & 4*).

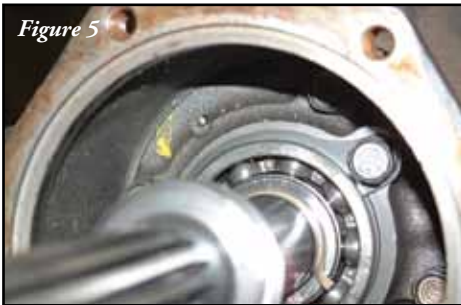
the entire main case and extension housing cavity equally. Since all of the cavities of the Hydro-matic were well vented, leaks were not an issue. By comparison, on the C.I. Powerglide the dipstick tube enters the case at a lower level. This means that - when the fluid is at its proper level - this area is isolated from the rest of the main case cavity. When all of the area inside a transmission case is not vented equally, pockets of pressure are allowed to build up. The vented area of the main transmission case and the extension housing are connected by an orifice in the 11 O'clock position in the rear pump (Figure 5).

This orifice was restricted by a small pin. Veteran C.I. Powerglide rebuilders learned the hard way that leaving the pin out of the orifice in the rear pump would cause the transmission to burp oil out of the dipstick. Before the vent was added to the main case in 1958, this burping action was the only way that a pressure build up could be exhausted from the main case. This pressure build-up also explains the numerous stubborn leaks.
