THE TORQUE CONVERTER JOURNAL

Volume 5 Number 2

Front Covers and Studs Staying Connected

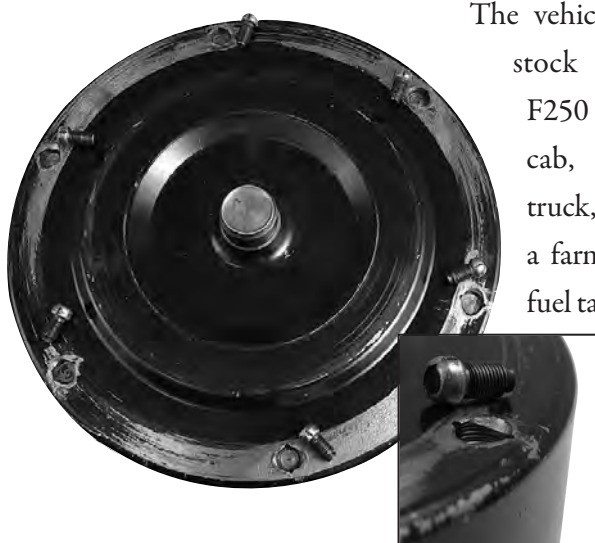
Figure 1 - Failed Front Cover

We recently had reason to review our long experience with stud welding. Several weeks ago a customer called to say he had a problem with what he thought was one of our Ford billet covers. He had rebuilt both the transmission and torque converter; it had been in service for about six months when all six converter studs failed.

rebuilt. When we got the failed cover (**Figure 1**), it was easy to spot that the billet cover was not ours by looking at the studs. These were threaded into the cover and secured by dowel pins to prevent the threaded studs from backing out. Sonnax studs are welded to the front cover (**Figure 2**).

It appears that the studs separated from the failed cover due to stress on the soft cover material. The holes in the cover are only .250" deep so the thread engagement is a maximum of .200" (**Figure 3**). This does not provide an adequate design safety factor. The length of the thread engagement securing the stud to the cover is about half that recommended to achieve full thread strength. Calculations show the shear stress area of the soft cover threads is greater than the 3/8-24 stud. The numbers appear adequate for pure shear applications; however, the short thread engagement and minimal safety factor may not stand up under harsh applications with diesel engines which can induce high torque oscillations. Whenever threads experience high cyclical loads, what starts

as vibration can cause minute distortion or thread wear, and the process of self-destruction begins.

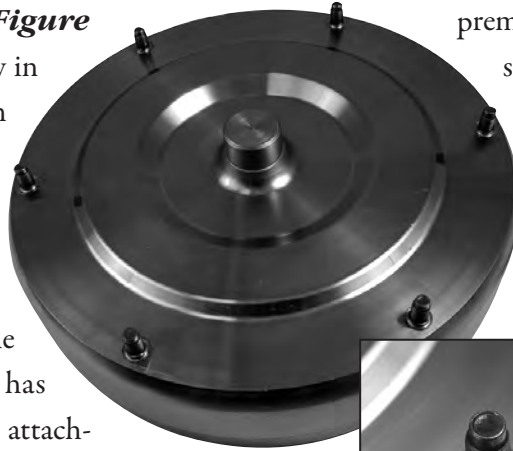
Figure 2 - Sonnax Front Cover

In comparing a Sonnax cover (**Figure 2**) to an intact version of the failed cover (**Figure 3**), key differences appear, especially in the critical contact area between cover and studs. Sonnax covers and studs are of higher grade steels for greater strength. The Sonnax threads are roll formed adding even greater strength to the threads. The stud welding process Sonnax has developed results in a high strength attachment that can only be achieved through melting/combining and quenching the cover and stud materials.

After welding, Sonnax machines the excess molten metal around the outer diameter of the stud to a .030" radius, which helps reduce the stress concentration at the base of the stud. This process also helps avoid any possible interference that might prevent the flex plate from mounting flush with the cover.

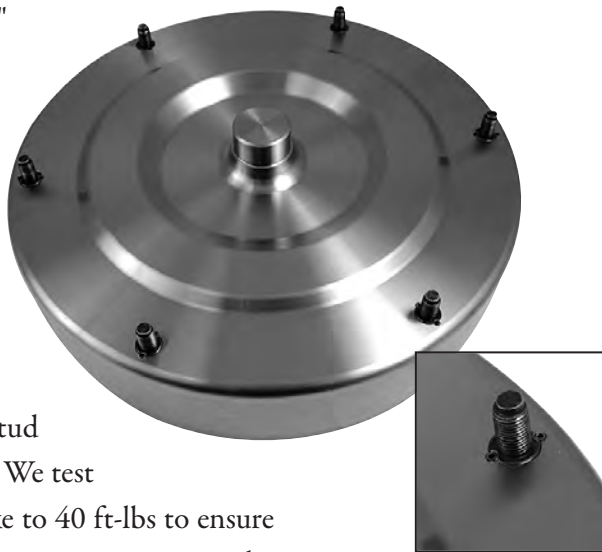
Figure 3 - Intact Version of Failed Front Cover

in **Figure 3**. All of the studs tested suffered premature thread stripping at 45-50 ft-lbs

so we were never able to determine if the stud cross-sectional strength met our minimal requirement. Given the poor thread strength, it is likely a mounted cover assembly would fail below our 60 ft-lb minimum requirement.
