## Converter Tech Tips

### 2002-Up 5R55N/S/W Converter Noise: One Shop's Solution

By Ed Lee

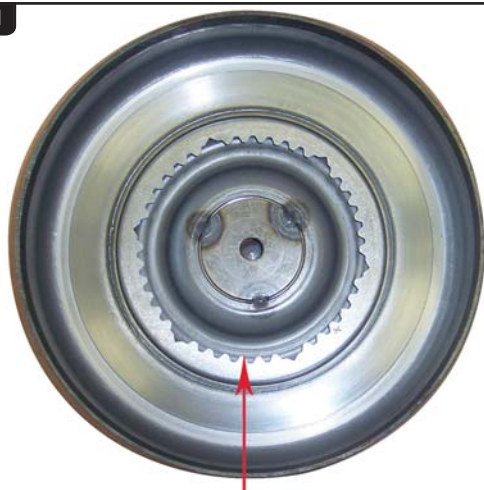
Figure 1

The peened contact area on the teeth is more evidence that this is where the noise is originating (see Figure 1). Mark Mustard from Branting Industries in Colorado noticed that the noisy converters had little or no drag when he put an input shaft into the turbine splines and rotated the assembly. The angle of the contact between the six anti-rattle springs on the piston and the cover exerts a forward force on the piston. Over time, as the springs weaken, the drag on the clutch becomes less (see Figure 2).

Impact loads raise an edge on the teeth.

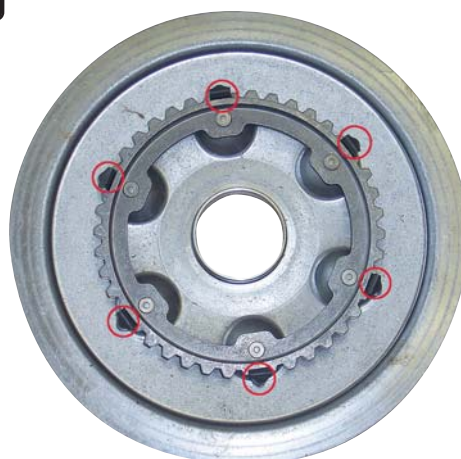
Figure 2

The six anti-rattle springs become weak over time.

Mark found that bending the springs back into shape increased drag and decreased the noise. Unfortunately, this is a short-term fix, because the springs soon return to their weakened state.
