# MERCEDES 722.3 Quickie Stator Repair

By Ed Lee

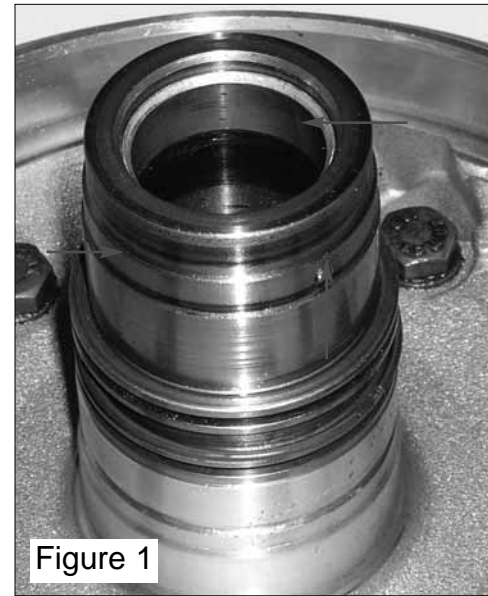
Figure 1

What happens is this: you're assembling the 722.3 transmission and find that spalling has occurred on the bearing surface at the rear of the support. (See Figure 1.) The pitted area, caused by the spalling, was missed during disassembly and clean-up, and now it's your problem.

If your stator support is pitted in this area there's now a way to save it.
