Article No.: EL_TC_08-06

Water contamination in torque converters

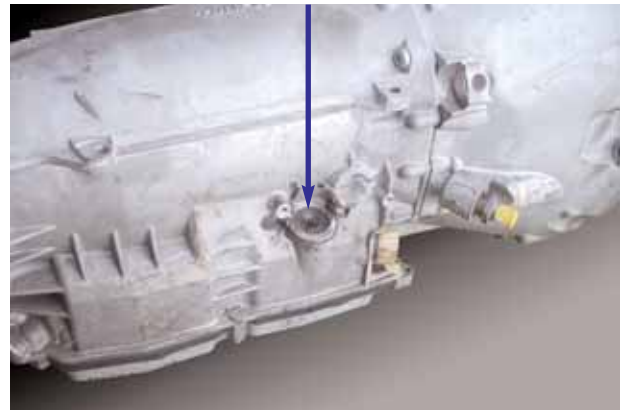
Figure 1

When a higher-than-normal number of converters are found to be contaminated with water, there's usually a common source that must be found. This was the case with the converters for the 2005 Jeep Grand Cherokees equipped with the 3.7L engines. The fill tube oil seal was allowing water to enter the transmission (see Figure 1). Most customers were unaware of the water in their transmissions. Some only noticed a TCC shudder or a slight buzzing noise. Daimler Chrysler became aware of the problem and issued Service Bulletin (SB) #21-011-05 REV. A. In October 2005 this bulletin was canceled and Safety Recall E13 was issued. The Safety Recall was issued because if the water entering the transmission is left unchecked, it's possible for the fluid

to rise to a level to cause foaming by the moving parts, and the expanding foam could escape onto the exhaust.
