Article No.: TASC Tip_07-07

Déjà vu all over again

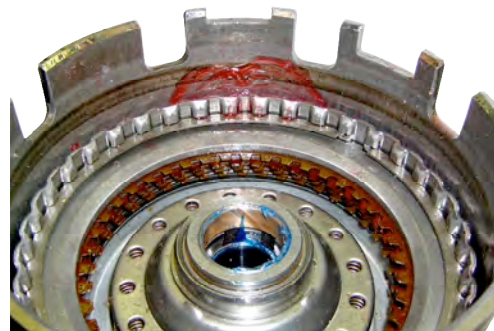
Figure 2 shows a drum being air-checked after a small amount of ATF was added between the inner and outer shell. Although the leak was very visible after the ATF was added, it was previously impossible to see. The only clue that the drum was defective was the burned clutches the technicians found during the initial teardown.

After the technician had eliminated all of the other possible causes for the burned clutches, he turned his focus to the drum. The technician's diligence paid off when he repeated the air check with the added ATF. After the second air check proved that the drum was leaking, the drum was cut in half at the point of the leak (see Figure 3).

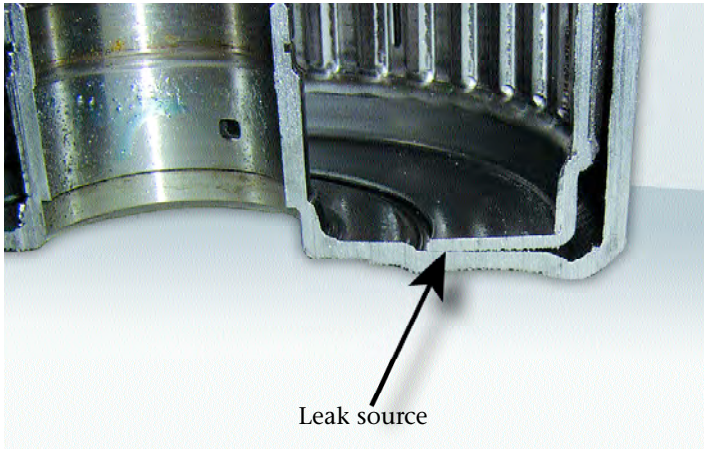
Figure 3

It was now easy to see that the inner liner was separated from the outer shell at the weld. We now know why hindsight has 20-20 vision.
