TCC apply & release problems

Stator Support Sleeve

76204-01

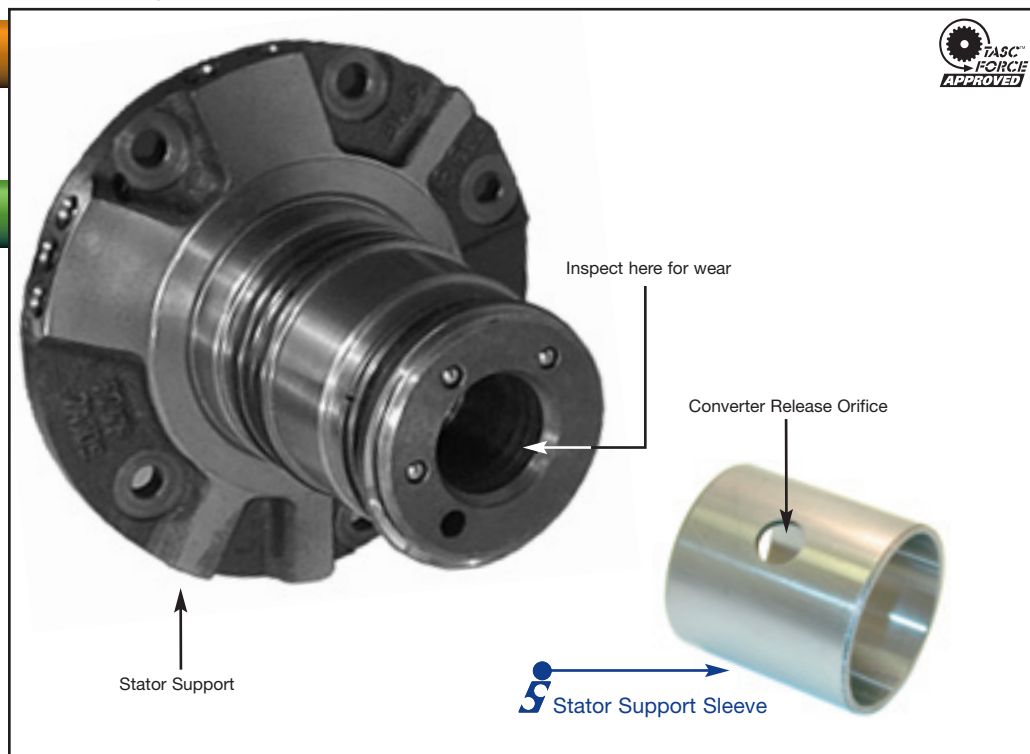
A worn stator support ID at the input shaft sealing ring area allows oil leakage.

Vehicles with an AODE and 4R70W transmission frequently have torque converter clutch apply and release problems as well as oil loss in various circuits. The sealing ring area on the input shaft can cause severe wear of the stator support, allowing oil circuit cross leakage. Converter release oil is fed through this area to release the TCC from the cover. When the lockup valve moves, this oil exhausts through the shaft. If the stator support bore is worn, the seals do not function properly. This can allow lube to flood the release circuit and create no lockup or shudder. Sonnax has developed a hardened steel sleeve **76204-01** that will eliminate these problems.

Machining the stator support to accept the Sonnax sleeve provides a new surface for the Teflon® sealing rings to isolate lube and release oil for the torque converter.

- Precision sleeve is designed to be pressed into a pocket machined in the back of the stator support, providing a new seal surface and restoring oil circuit integrity.
- Hardened steel sleeve resists wear.
- Sleeve supplies additional support to the input shaft.
