## 4R70W ('95-HIGH MILEAGE)

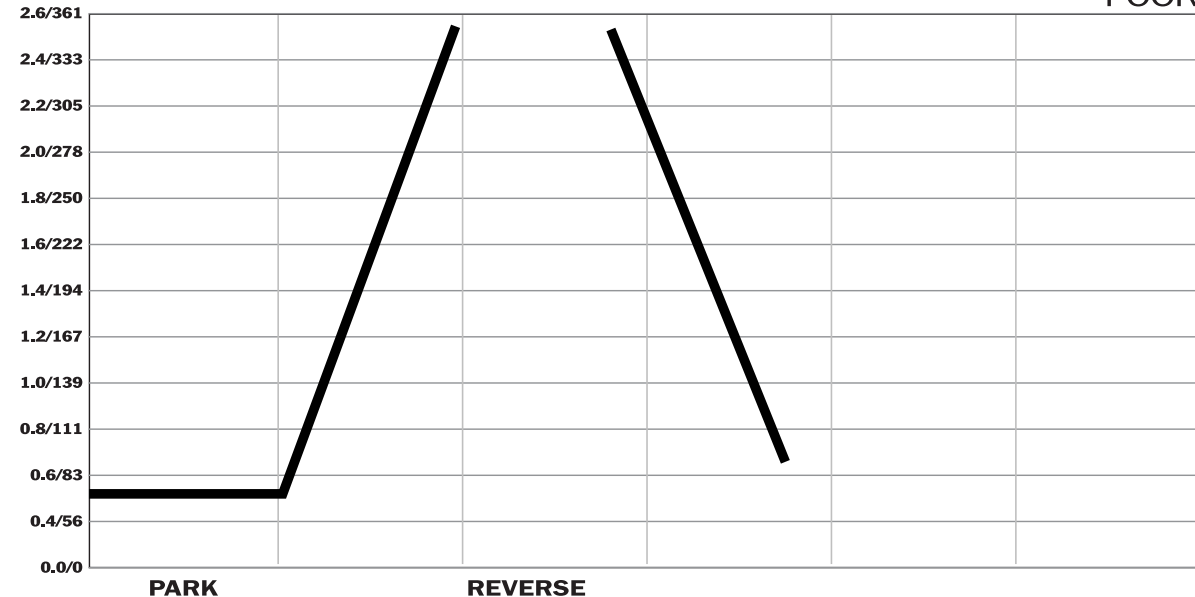
GPM/HZ

**Condition:** Aerated fluid (pump grabbing air), poor suction porting, gaskets, etc.

*Notes: Initial start, then reverse engagement. Can occur at end of 1-2 shift.*

**Correction:** New pump, Sonnax Bypass Clutch Control Sleeve & Plunger Valve **76948-04K**, pressure regulator valve and converter regulator valve.
