Article No.: TCTIP-02-10

Author: Ed Lee

Torque Converter Forensics Honda 740 Codes

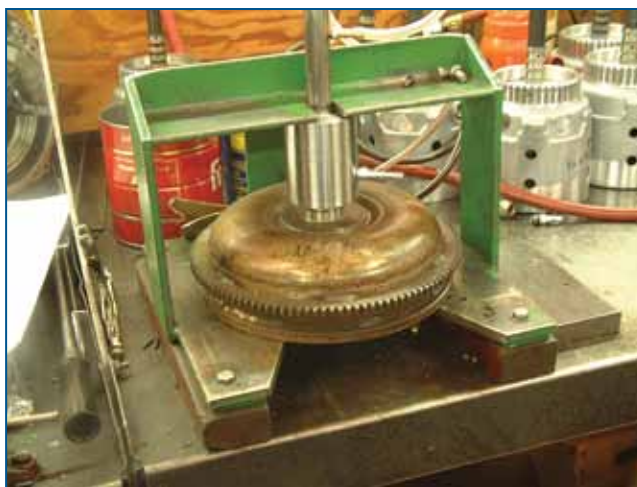
Figure 1

there is no provision for a positive seal. The other two areas (turbine shaft to turbine hub and turbine hub to TCC piston), rely on the clearance between the mating parts to establish their seal. The most likely area for the leak seemed to be between the turbine shaft and the turbine hub, but to be certain,

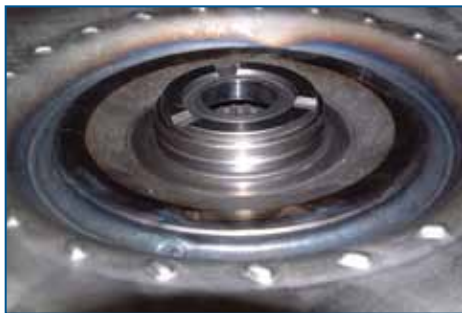
Figure 3

The hardened surface turned out to be only a few thousands of an inch deep and the hub machined easily. **Figure 3** is the turbine hub after the groove is cut, and **Figure 4** is the same hub with the late model seal installed.

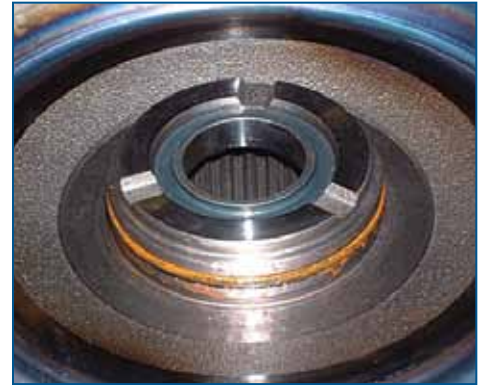
Figure 5

a General Motors (GM) 245 mm converter for its seal. Their converter tested best of the lot on the lock-up clutch test fixture (holding over 150 ft/lb of torque at 20 psi). (**Figure 5**)

The ultimate test was to put this converter into a vehicle with a 740 code. To date, the converters with the added sealing ring have a 100% success rate. The folks at Consolidated Vehicle Converters of Kettering, Ohio used an o-ring from

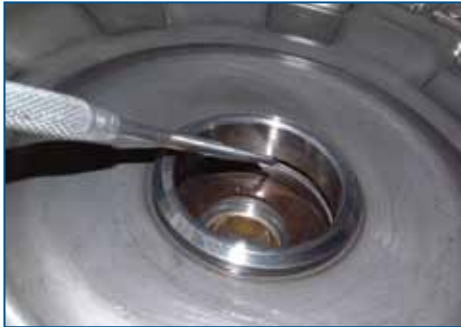
Even though the seal cured the test converters, some of the late model Odyssey converters that already have the O.E. seal, still have lock-up problems. The problem with these converters has turned out to be a clearance issue.

surface on the cover or clutch bonding surface on the piston will make this clearance even less. **Figure 6** shows the proper clearance between the piston and bearing race. The outer bearing race

normally protrudes out of the cover about .030". If the piston comes into contact with the outer bearing race before the piston comes to a complete stop during lockup apply, it will rotate the race in the cover. On occasion the rotation of the race will recess the race down to a point that the top will be flush with the cover. This will affect both the overall height and clutch release clearance of the converter. To get the piston to bearing clearance to the proper tolerance, measure the clearance between the piston and bearing outer race, then machine the front of the piston at the I.D. It is usually only necessary to remove about .030" to .040".
