Indexing TCC Piston/Damper Assemblies to Turbines

By Ed Lee

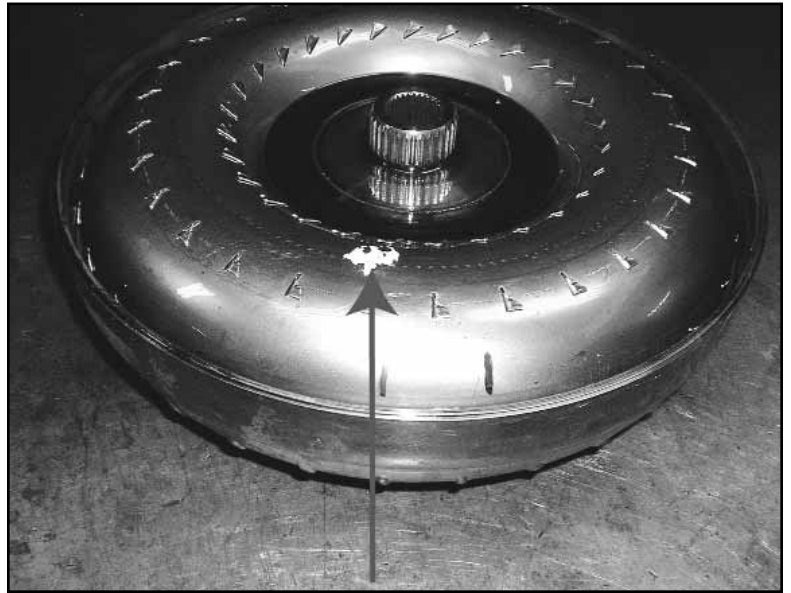
Figure 1

When the OEMs build a converter, they balance the turbine and the clutch individually to a tolerance of 1 gram-inch. The two components are then mated together, with the heavy spot of the turbine indexed directly opposite the heavy spot on the clutch. On the 298mm GM converter, the heavy spot on the turbine is located where the balance weight was added. This spot is marked with a paint dab at the factory (see Figure 1).

Since most pressure washers are not ink spot- or paint dab-friendly, scratching an "X" across the paint or ink dab would be a good habit to cultivate. This is especially helpful if the original part is less than 1 gram-inch out of balance and no modification is necessary (no weight added, no weight removed).

A good rule of thumb is to index the heavy spot of the turbine (where the weight is added) opposite the heavy spot of the clutch (where the weight has been removed). This will prove beneficial even if your shop doesn't have a balancer.

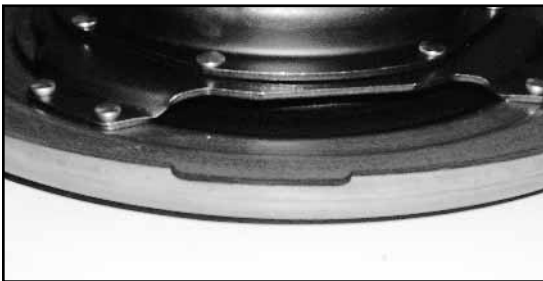
Figure 2

The paint dab is usually light gray in color, but unfortunately, the paint dab usually disappears the first time the part is cleaned in a pressure washer. Remember that the turbine is balanced to a tolerance of 1 gram-inch or less, so the heavy spot will be from 0 to 1 gram heavier. The heavy spot on the TCC clutch is located where the notches of metal were removed from the skirt of the piston for balance purposes (see Figure 2).

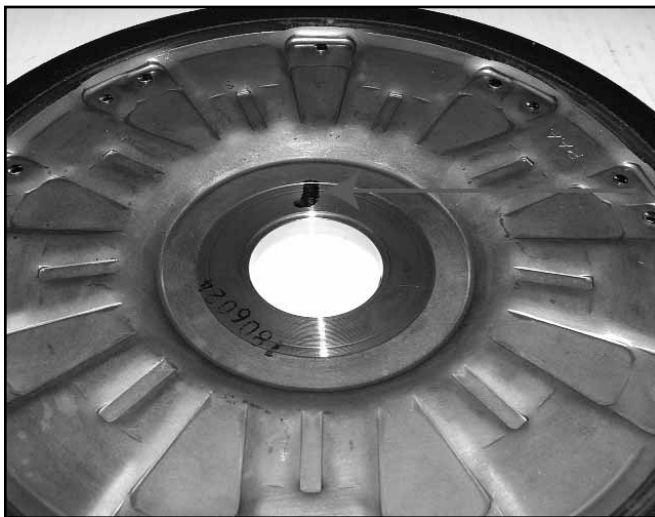
On some of the import TCC pistons you may find an ink dab marking the heavy spot. Figure 5 is a good example of this on a Honda TCC clutch. The weight on a Honda turbine is indexed on the opposite side (see Figure 6).

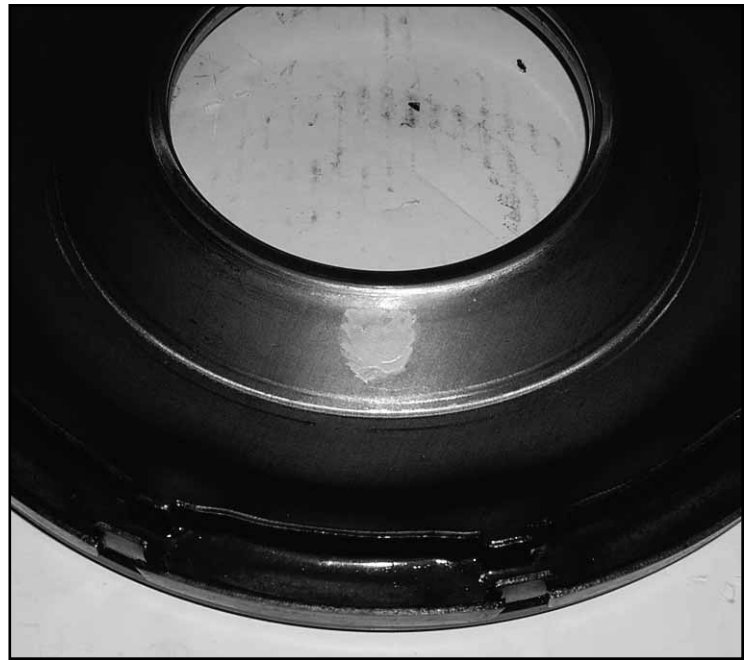
Some 500 and 518 TCC pistons have a paint dab like the one seen on the 298mm GM turbines. The paint dab can be either on the front or back side of the clutch and lines up opposite the weight on the turbine. The 518 piston in Figure 3 has the paint dab on the back.

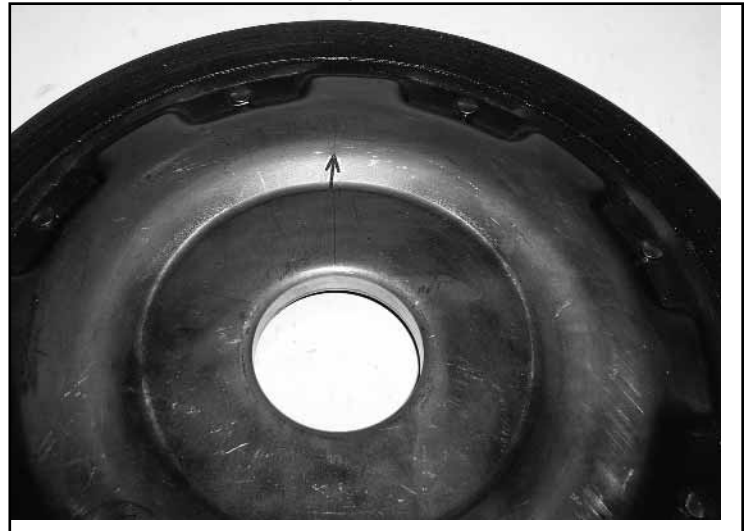
Figure 4

On the Cummins TCC clutch the heavy spot is marked with a stamped arrow (see Figure 4).

You may have noticed that the wear in the bore of the Cummins piston is always on the side of the bore that is opposite the notches in the piston and the arrow.
